George Miller Regional Trail

A San Francisco Bay Trail Segment in Steep Terrain

19 January 2016

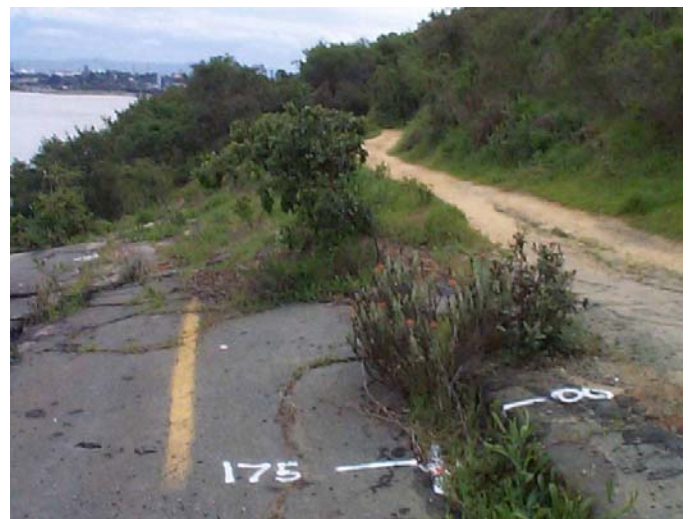
Figure 2. A large landslide at Station 176 closed Carquinez Scenic Drive permanently in 1983.

Station 176: A 200-foot-wide embankment and slope failure with complete loss of 100 feet of road embankment and up to an 18-foot-high headscarp. Failure is possibly a consequence of previous removal of the slope toe for railroad construction.

Station 176: A 150-foot-wide cut slope failure with flow of material onto road. Veneer-type failure of weathered rock cut. Failure material consisted of fine material up to large boulders. Potential for future failure.

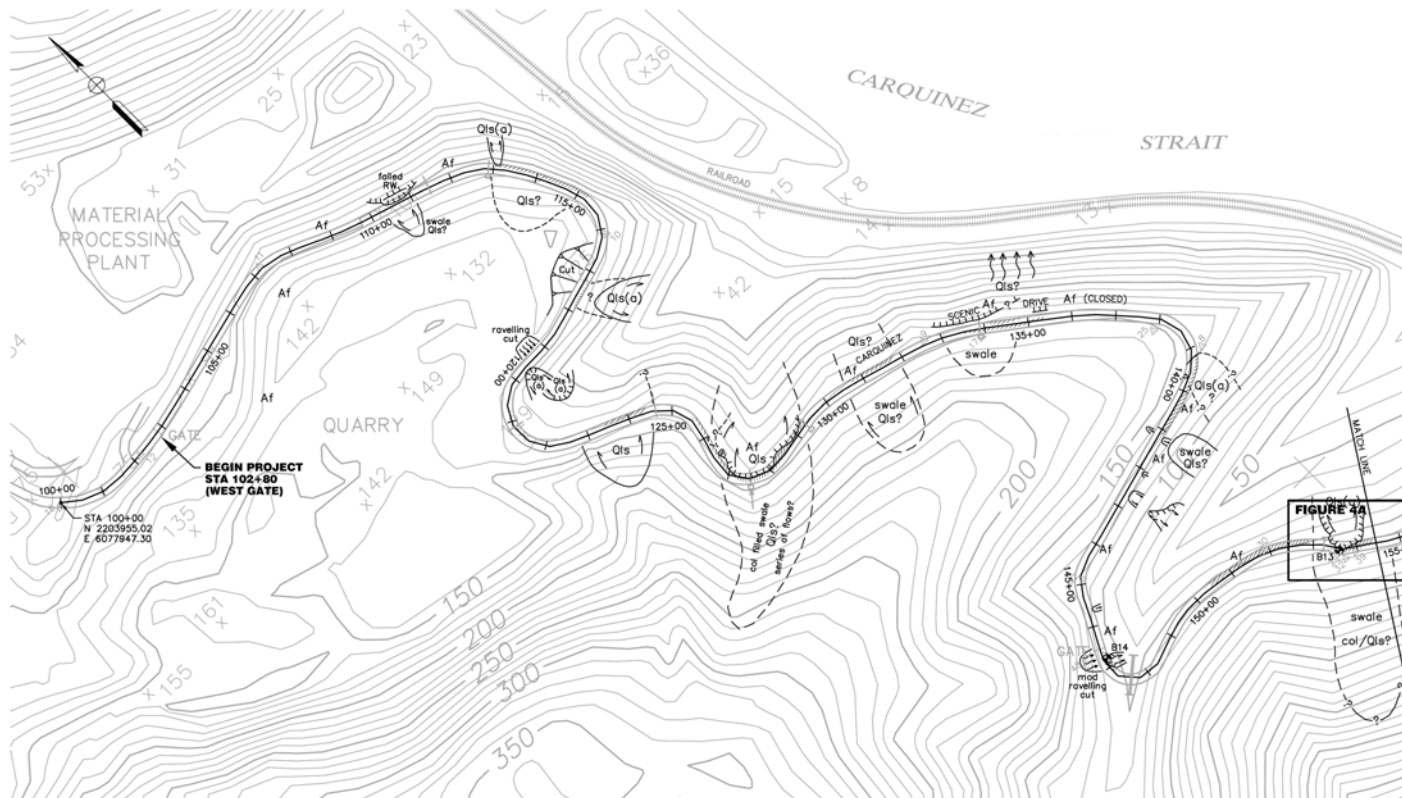
Figure 3A. Geologic mapping of the northwestern half of the trail

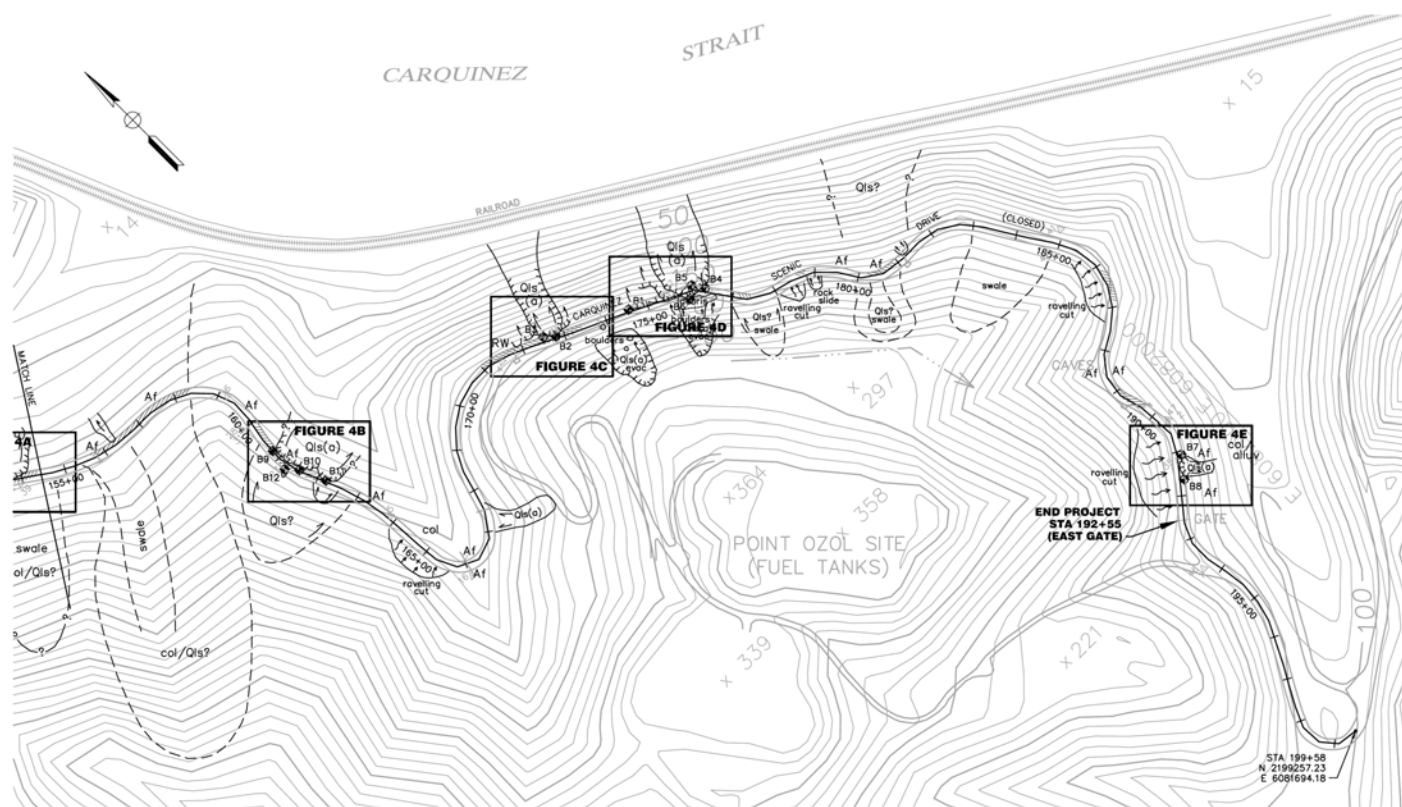
Figure 3B. Geologic mapping of the southeastern half of the trail

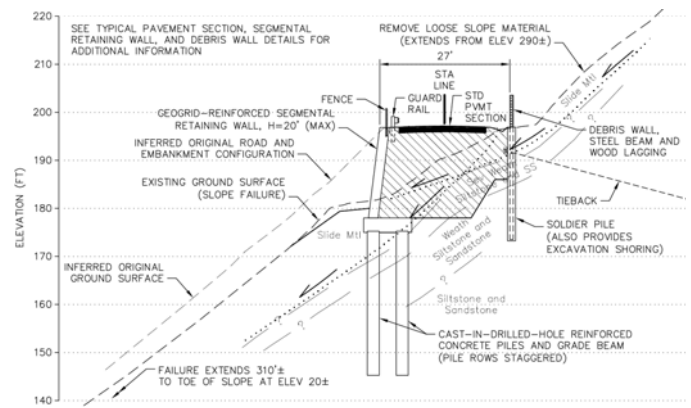
Figure 4A. Conceptual design alternative for Station 176 showing geogrid-reinforced segmental retaining wall supported by cast-in-drilled-hole reinforced concrete piles and grade beam

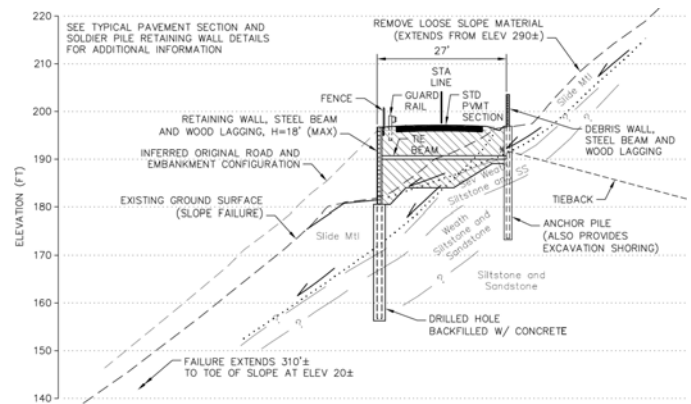
Figure 4B. Conceptual design alternative for Station 176 showing a soldier pile and lagging retaining wall laterally supported with steel tie beams connected to an upslope row of anchor piles with tieback anchors

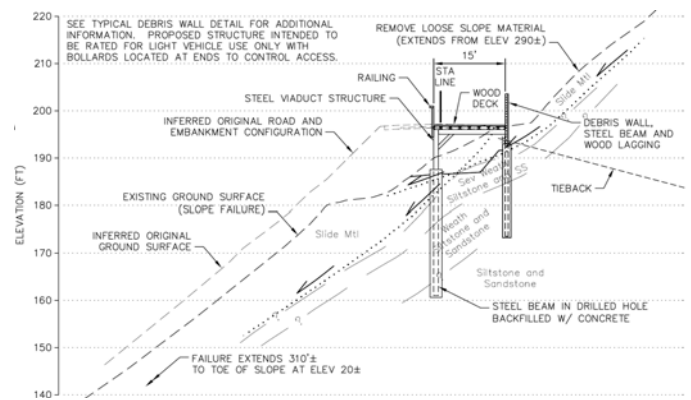
Figure 4C. Conceptual design alternative for Station 176 showing a steel viaduct structure supported on pile foundations with tieback anchors to allow landslide debris to flow underneath

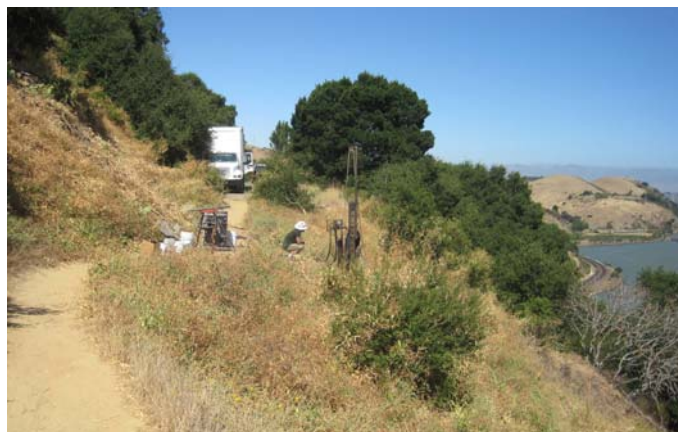
Figure 5. Portable hydraulic drilling rig situated on 1.25H:1V slope at large landslide at Station 176 (same view as Figure 9)

At Station 176, the location of the largest slide, access to the site was extremely difficult and drilling crews had to excavate steps by hand 25 feet up the steep landslide debris to the drilling pad. Care was taken to not destabilize the 6-foot-diameter boulders that littered the slope above and not to allow debris to fall down the slope to the busy railroad line 200 feet below.
