# The Development of the AASHTO/AWS Fracture Control Plan How it Relates to Historic Bridges

Karl H. Frank  
Hirschfeld Industries

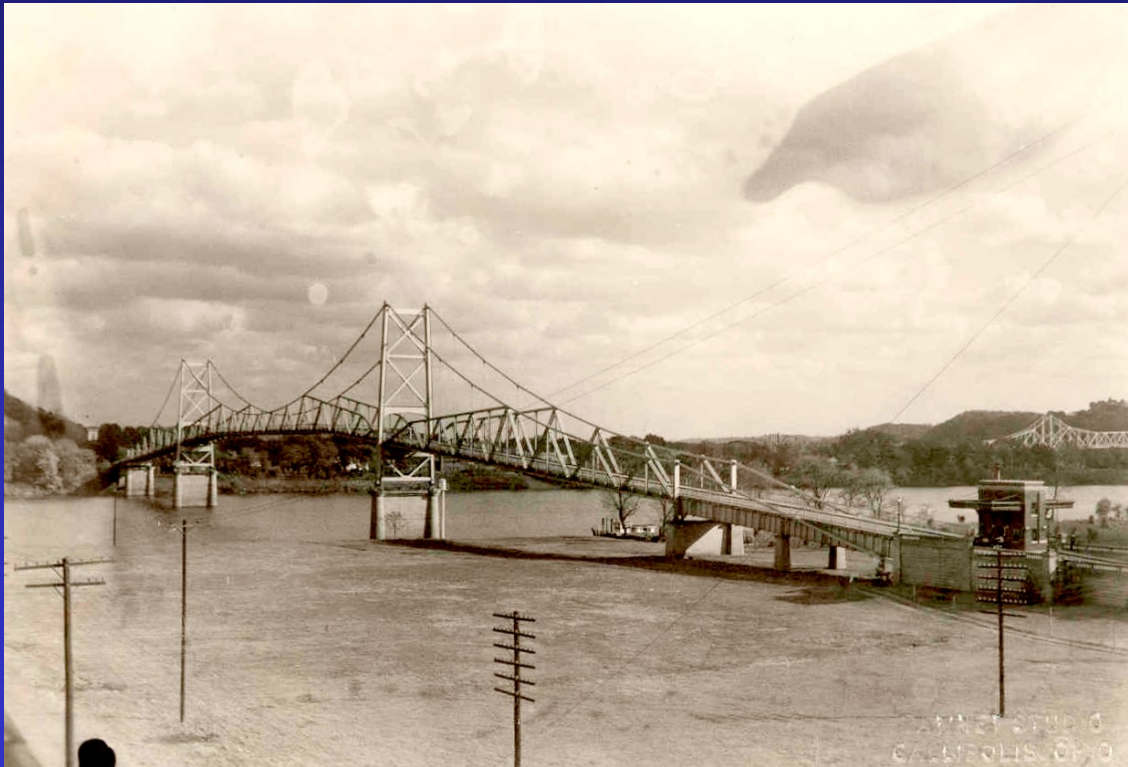
# Point Pleasant Bridge Collapse

- Eye bar chain suspension bridge
  - Designed as cable suspension bridge
- Built in 1929 collapsed 1967

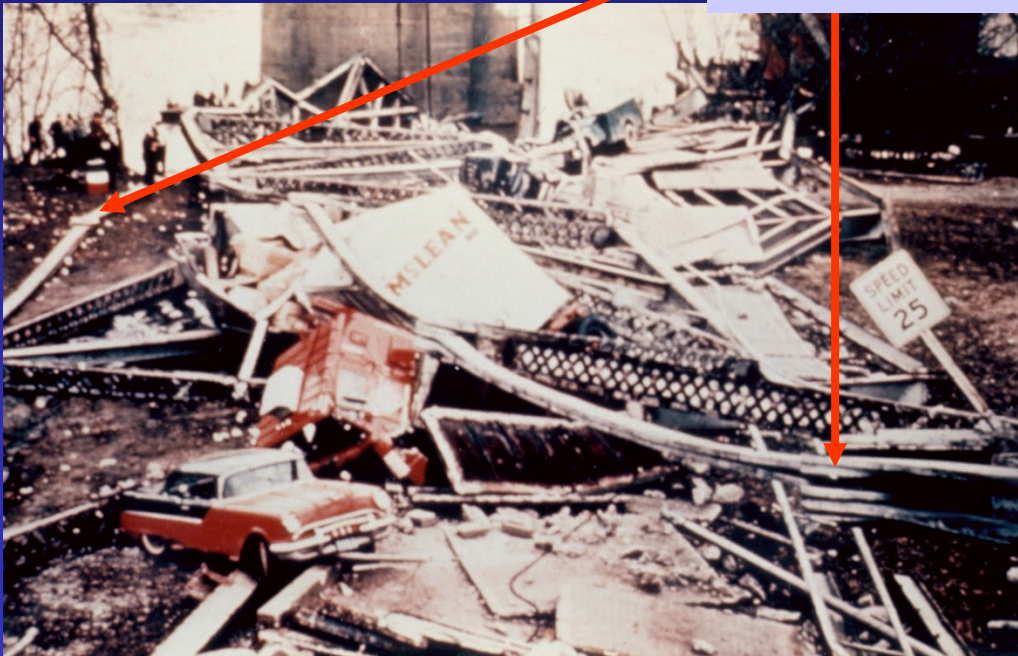
# Total Bridge Collapse

Eye Bars  
Chain- Pin  
Connected

- Bridge Reassembled on Land to Determine Cause of Fracture
- Note Eye Bar Chain
- One Lane of Bridge Backed Up at Time of Collapse

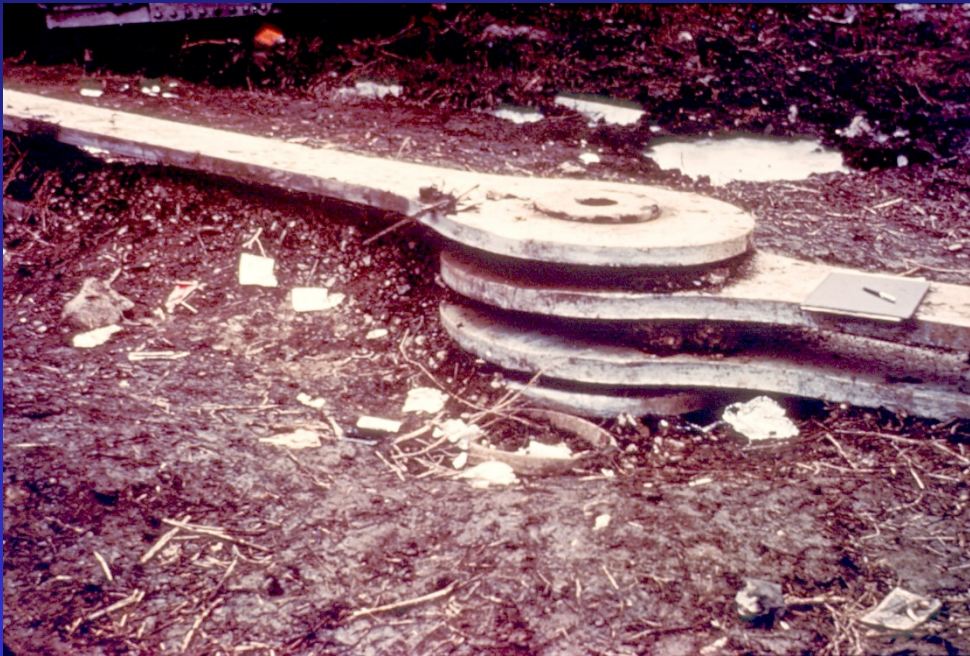
# Eyebars

- Pin Connected
- Two Bars per Chain
- Thickness varied along bridge
- Heat Treated 1060 steel
  - High Carbon (0.60%)
  - Low Toughness
  - Relatively High Strength

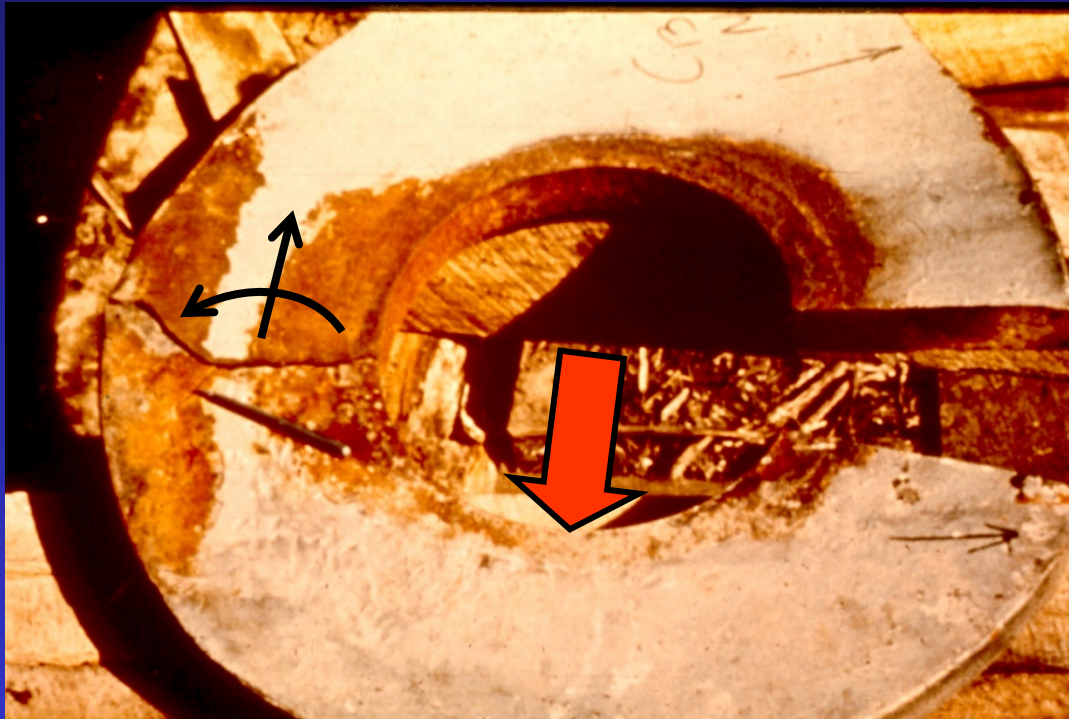
# Fractured Eye Bar

- Left Side Ductile Bending Fracture
  - Paint Spalling Due to Large Plastic Strain
  - Almost Full Section Plastified
- Right Side No Ductility
  - Low Toughness Brittle Fracture

1. Brittle Fracture of One Side of Eye
2. Remaining Ligament Under Axial + Bending Due to Eccentricity
3. Ductile Failure of Ligament Causing Force Transfer to Intact Eyebar
4. Eccentricity of Force From One Eyebar on Joint Causes Joint to Rotate and Unfractured Eyebar Pulls Off of Pin

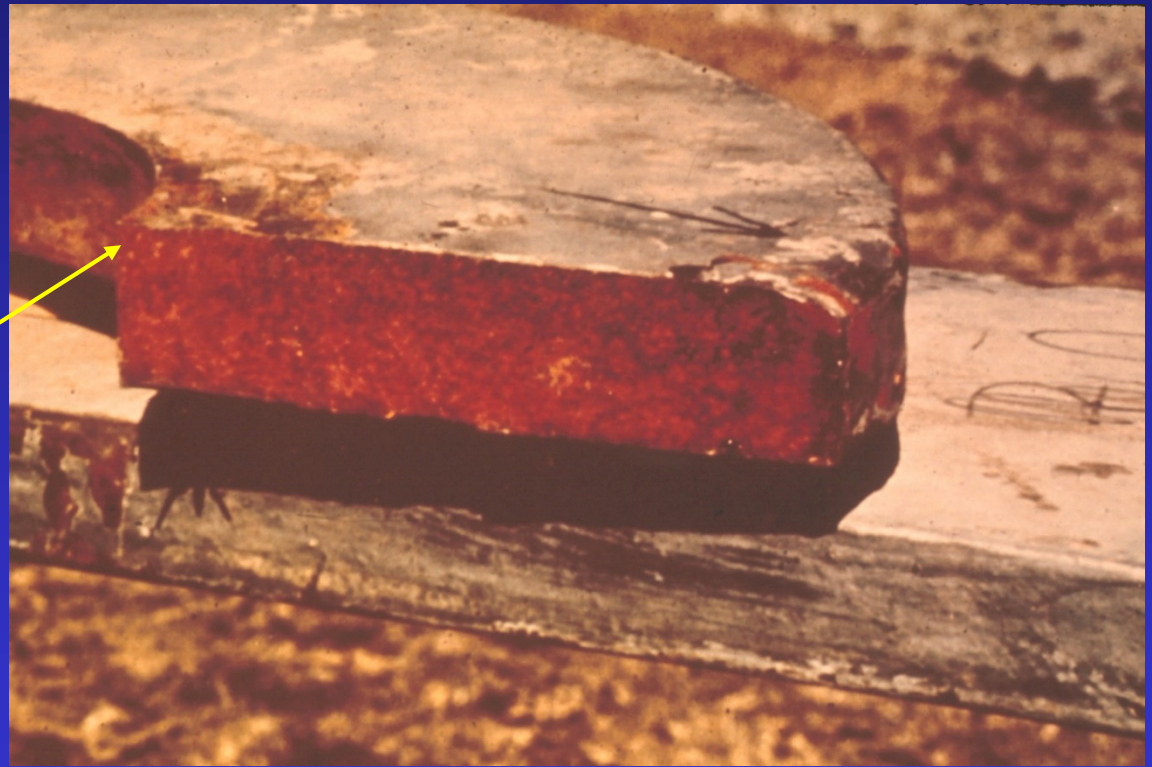
# Fracture Surface

Origin

No Evidence of Ductility

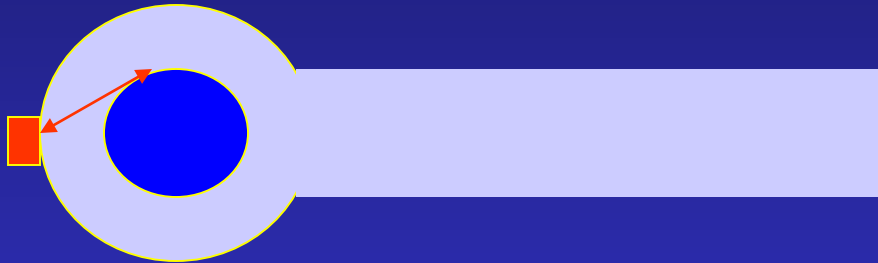
- Inspect Eyebars on St. Mary's Bridge
- Ultrasonic Inspection from Edge of Bar

- Difficult Access in Winter with Ice on Eyebars
- Inspectors Quit Due to Fear of Falling
- Unable to Differentiate Between Corrosion Pits on Pin Hole and Shallow Cracks
- Result: Bridge Taken Out of Service and Torn Down

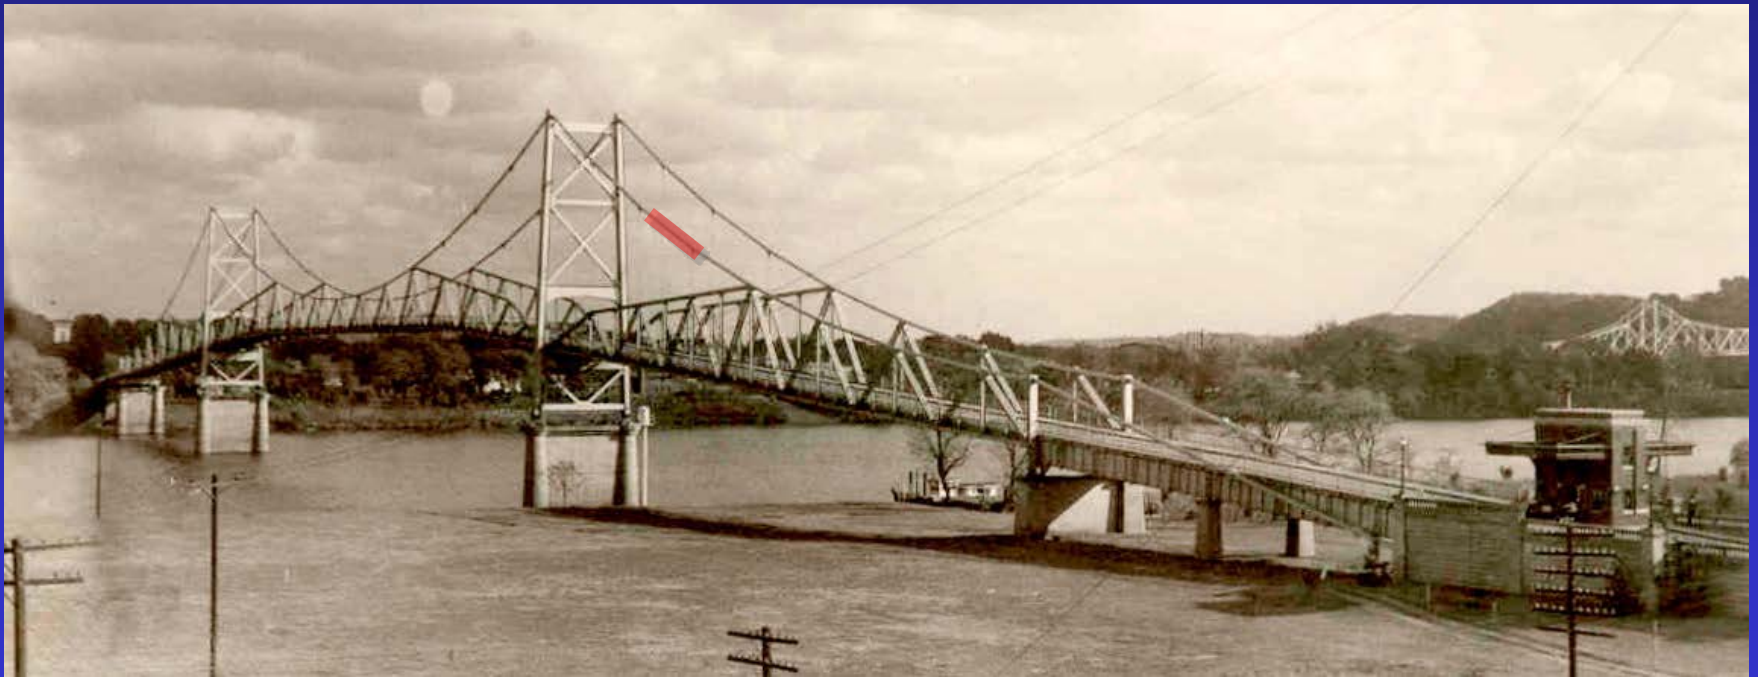
# Eyebar was defined as Fracture Critical

- Failure of Single Eyebar Caused Failure  
These Types of Member Labeled as ***Fracture Critical!***
  - These members are required to be “hands on” inspected at least every 2 years.
  - More Stringent Toughness Specifications
  - Enhanced Welding and Shop Inspection Requirements
- Truss Lower Chords are Typically Fracture Critical

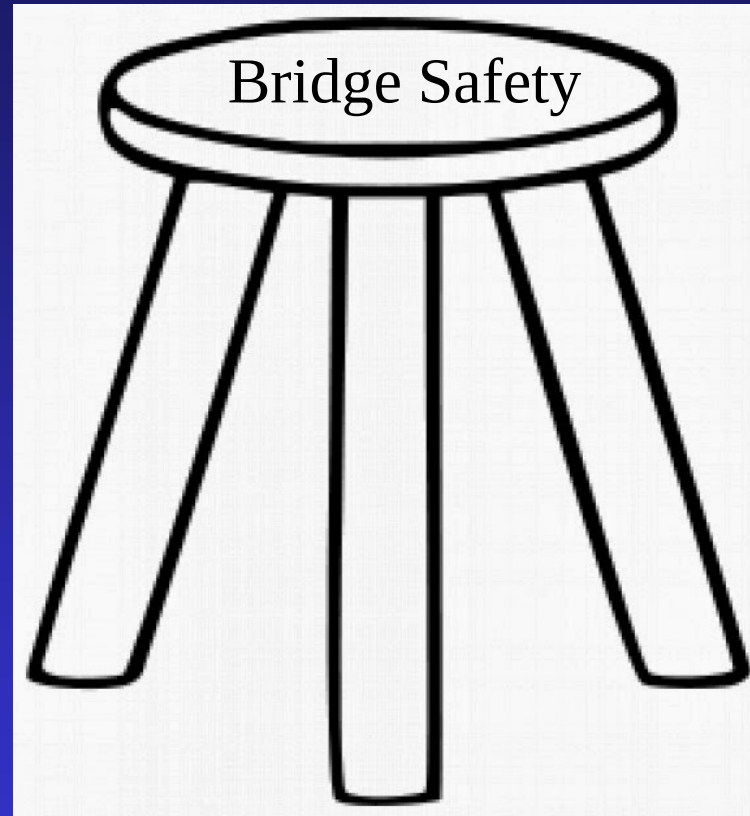
# The Fracture Control Plan

Enhanced Welding  
and Shop  
Inspection- Reduce  
Initial Flaw Size

Field Inspection-  
Looking for Fatigue  
Cracks

Toughness Specifications for  
Steels – Provide Inspect Ability

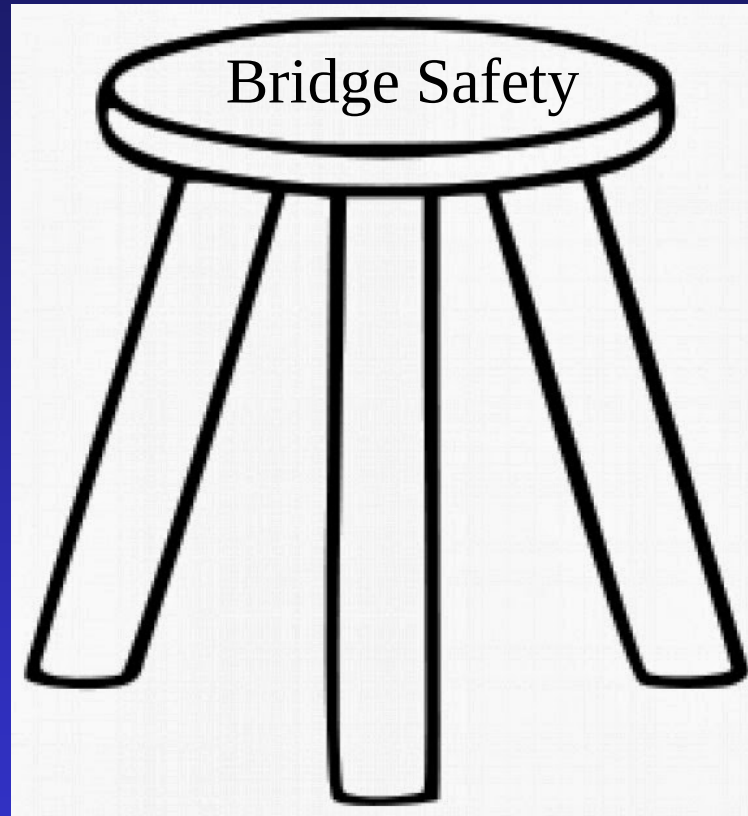
# Older Bridges

Enhanced Welding  
and Shop  
Inspection- Reduce  
Initial Flaw Size

Field Inspection-  
Looking for Fatigue  
Cracks

*Low Stress, No Welds*

Toughness Specifications for  
Steels – Provide Inspect Ability

***Toughness???***

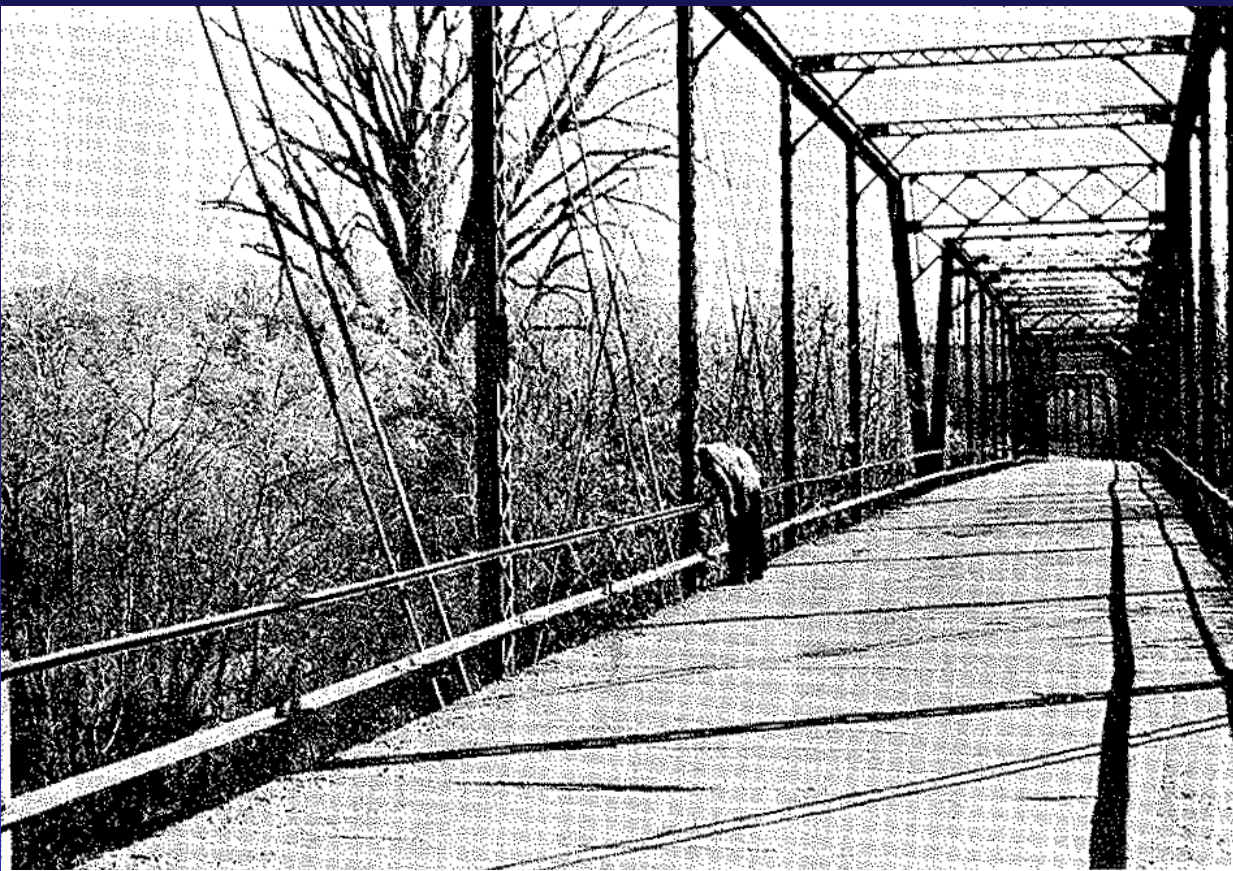
# Experimental Studies of Eyebars

- “Ultimate Load Behavior Full-Scale Highway Truss Bridges”- Sanders et al, Iowa, 1975.
- “Mechanical and Chemical Properties of Selected Steels used in Bridge Structures”, Frank, FHWA, 1974.

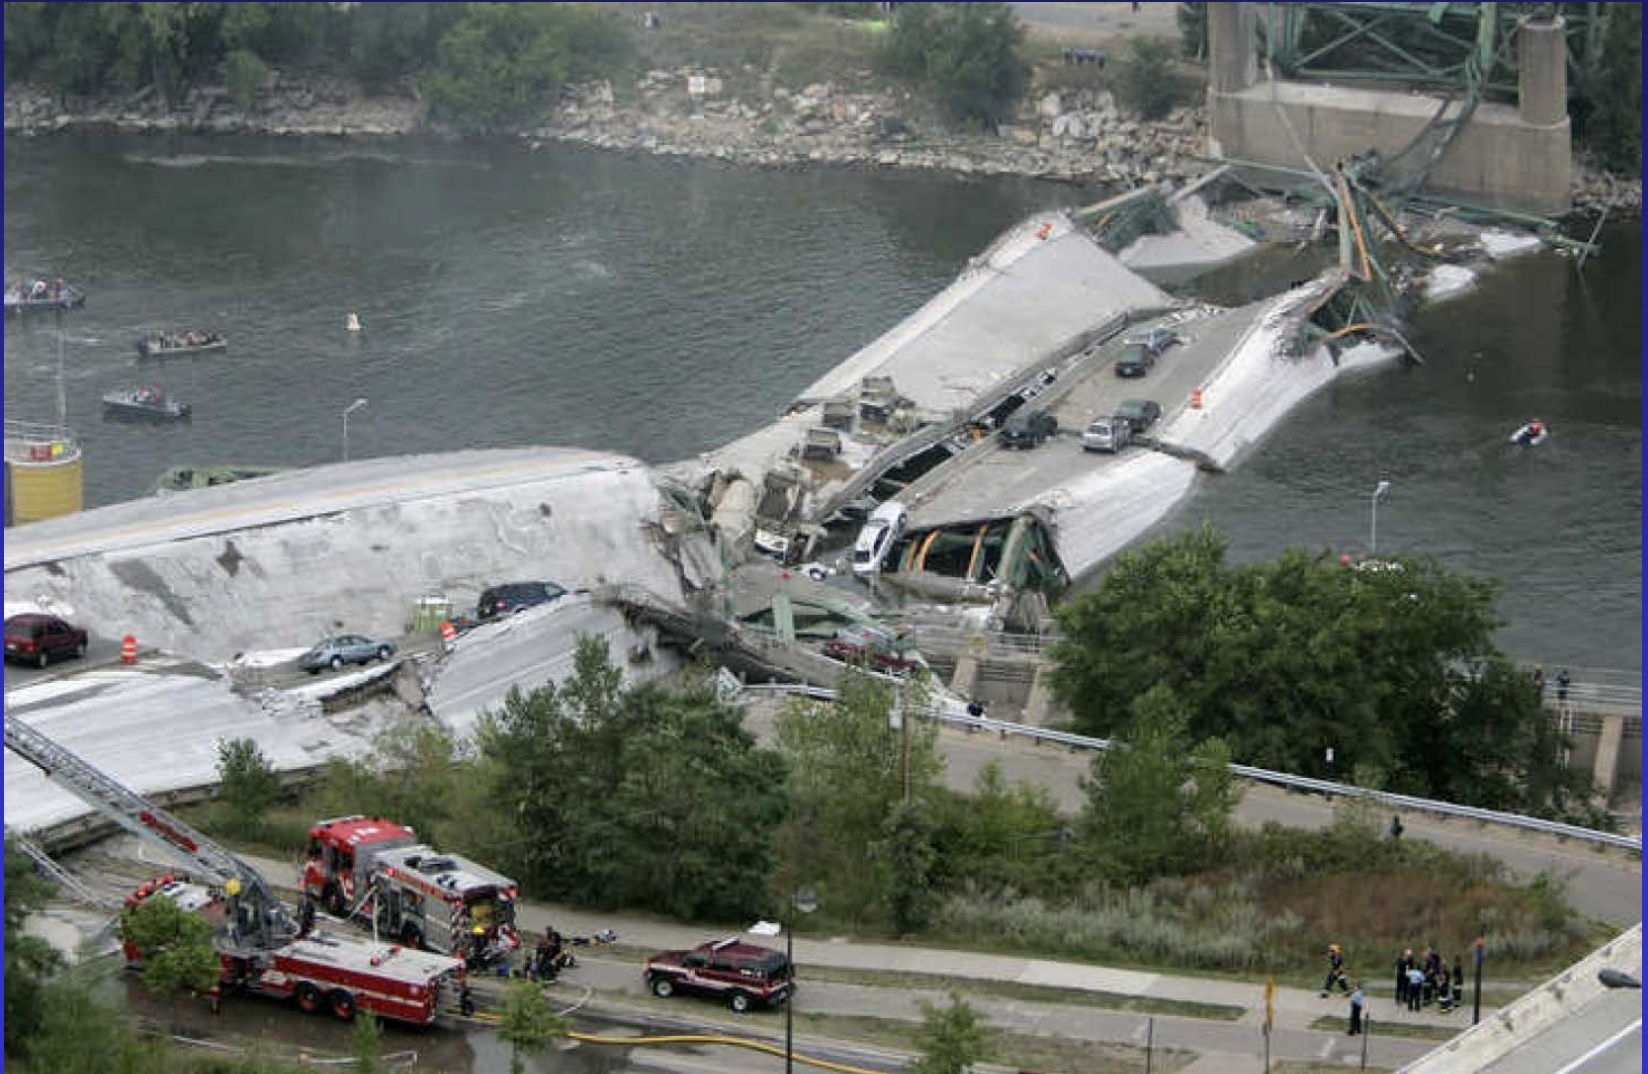
# I35 Bridge Collapse

- I35W Collapse was Due to an Error in Specifying the Correct Gusset Plate Strength
  - Designed using Grade 100
  - Specified Grade 50
- Inspection and Concern Focused on Internal Tack Welds
  - Buckled Gusset Plate Noted-Checked Drawings
  - No Analysis Check of Gusset Plate Strength
    - Simple Shear Check Would Have Caught Problem

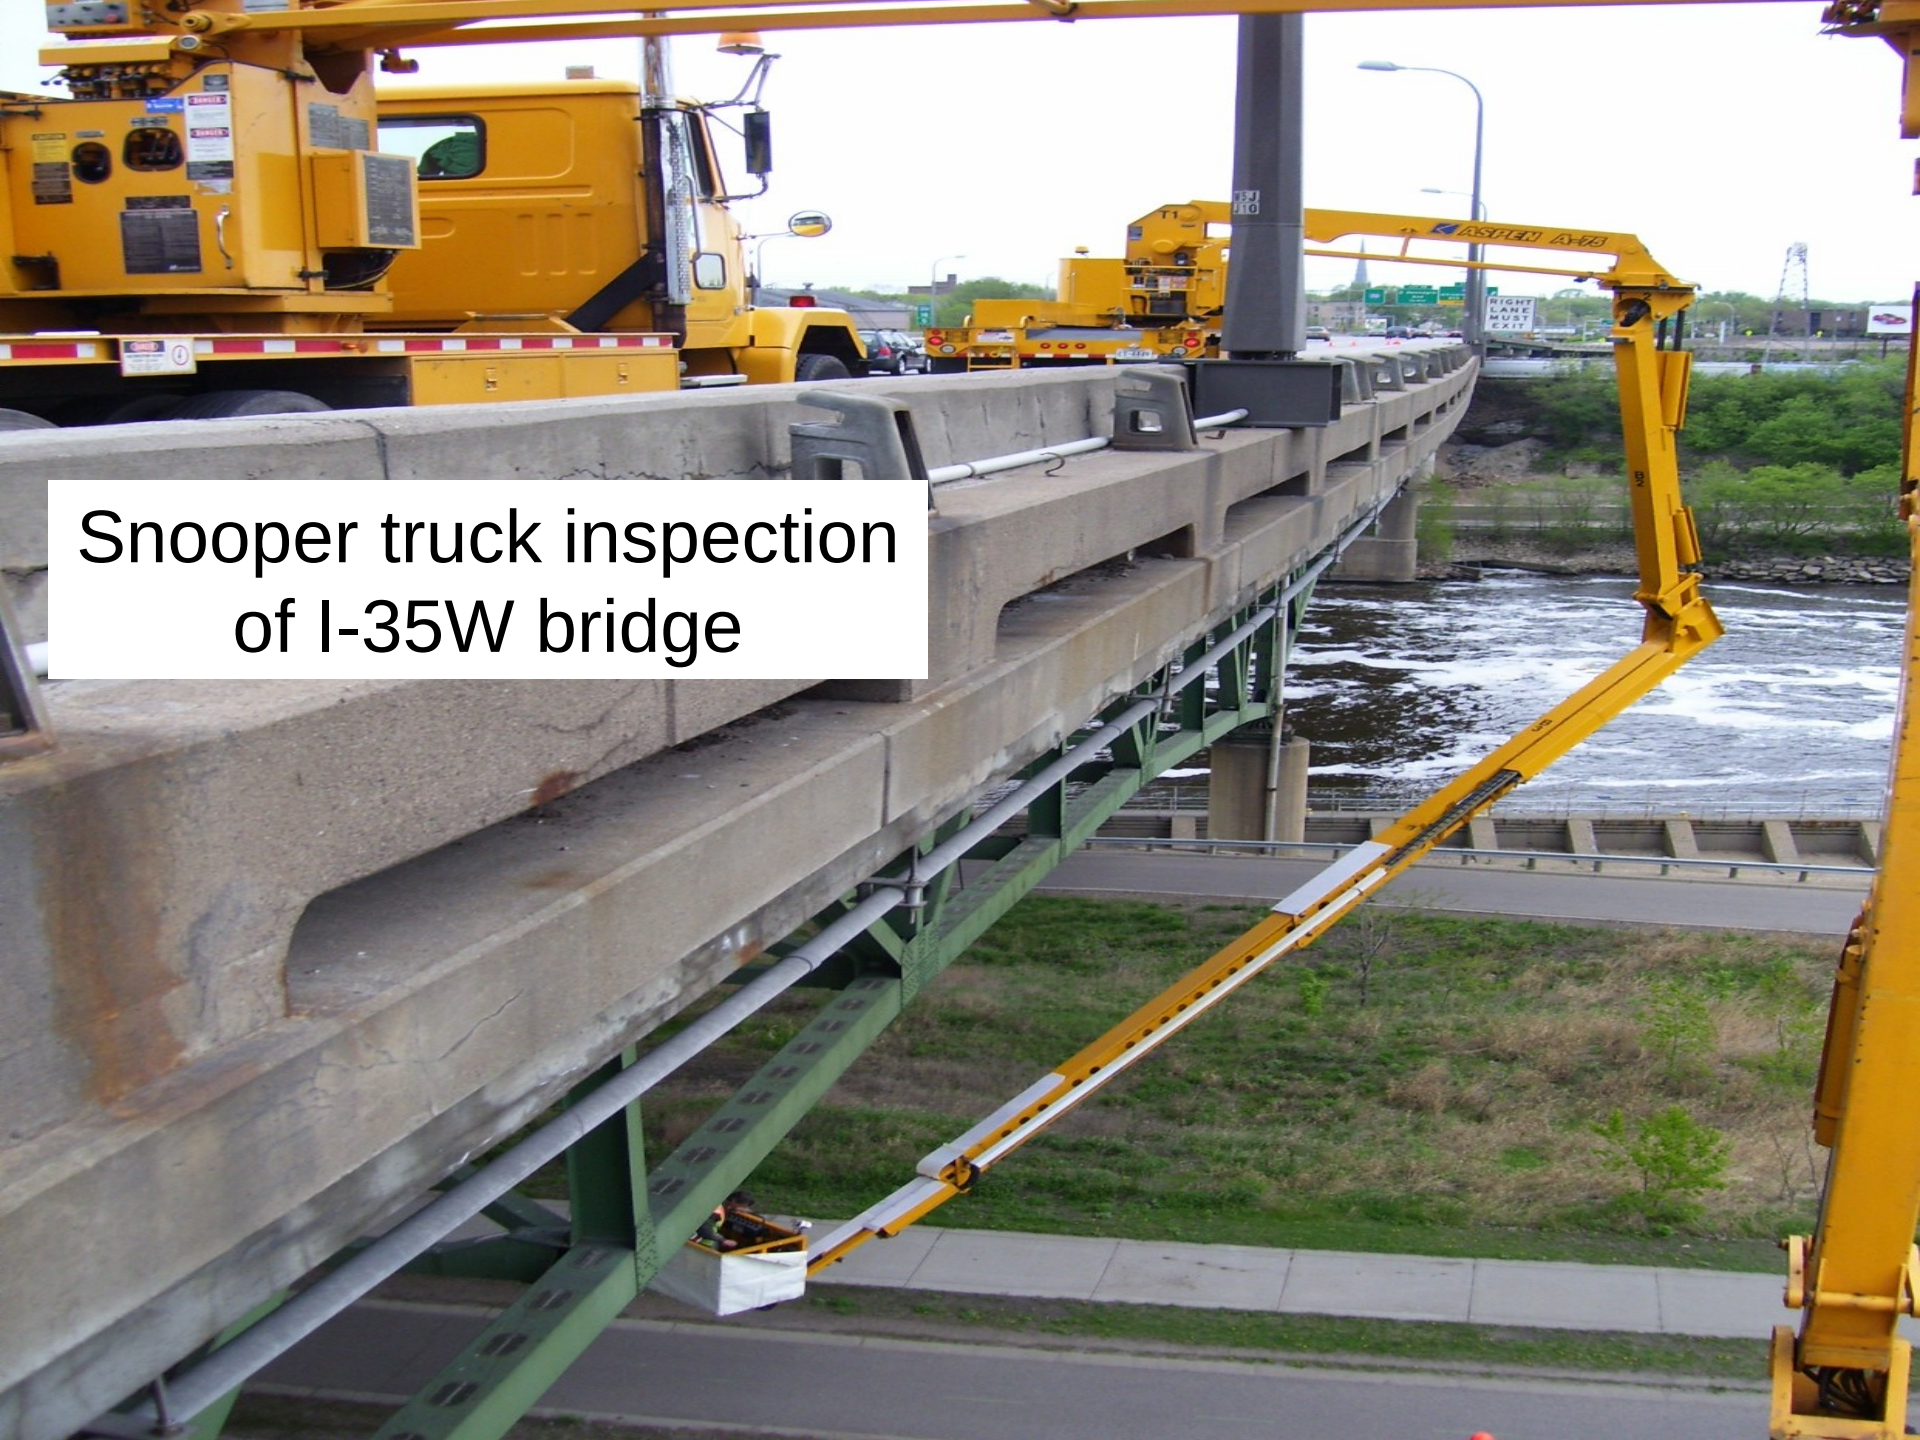
Snooper truck inspection  
of I-35W bridge

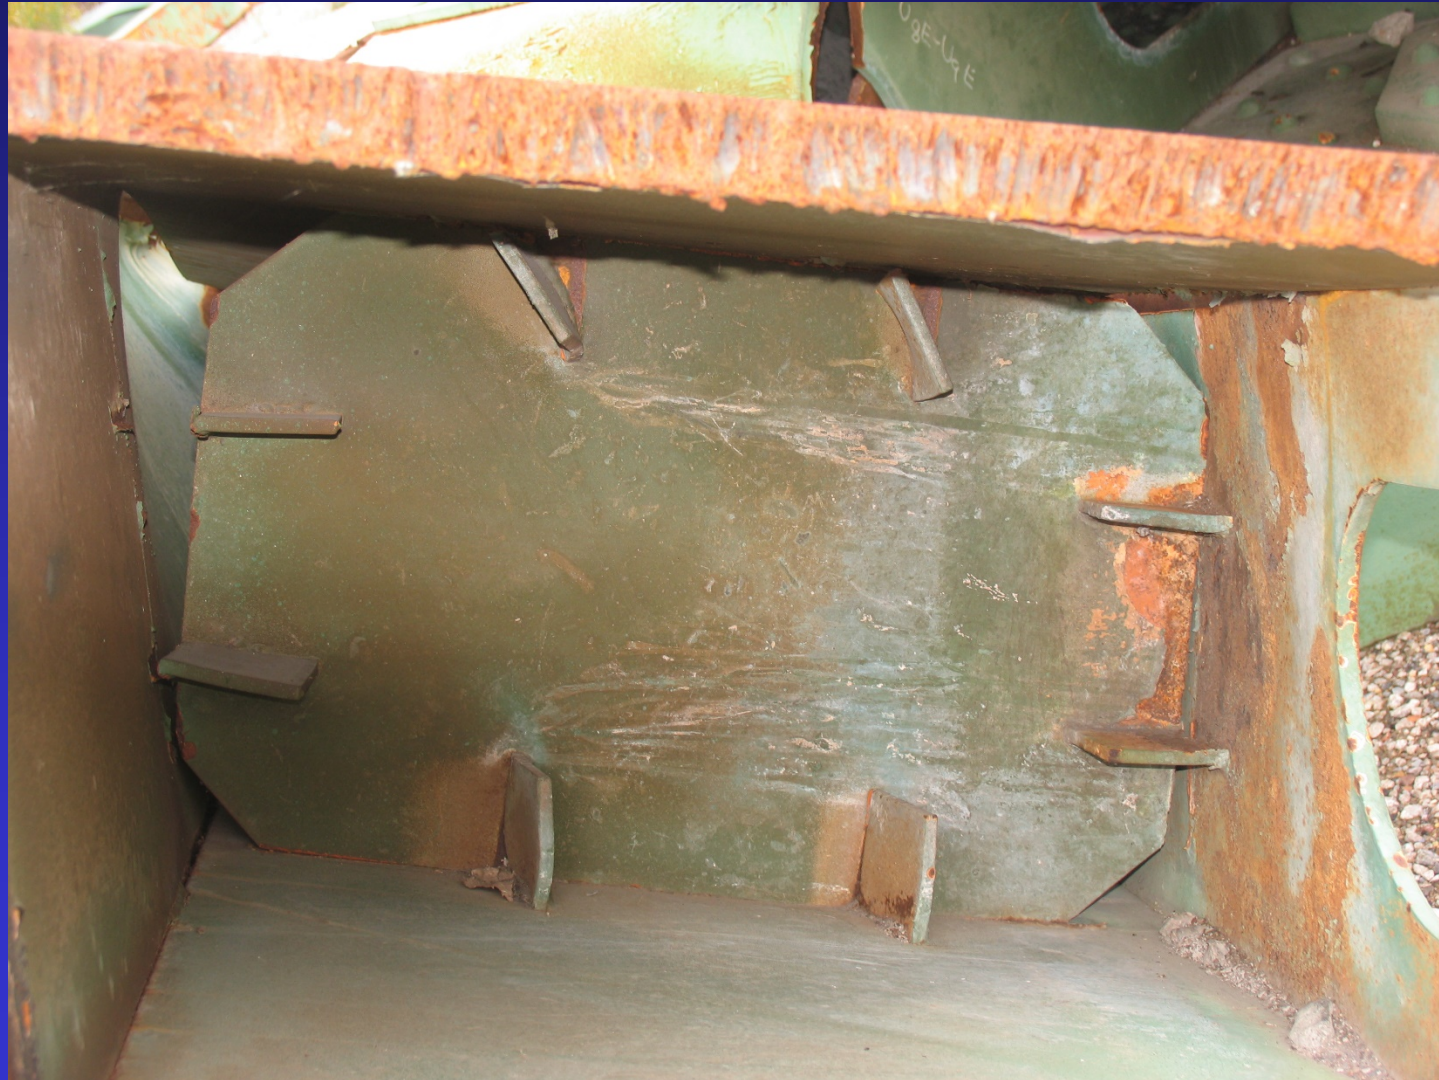
# Major Concern Was Fatigue Cracking From Tack Welds of Fit-up Plates Inside of Box Members
