# Historic Metal Truss Bridges: Restoration and Reuse

Presented By Nels Raynor,  
Bach Steel

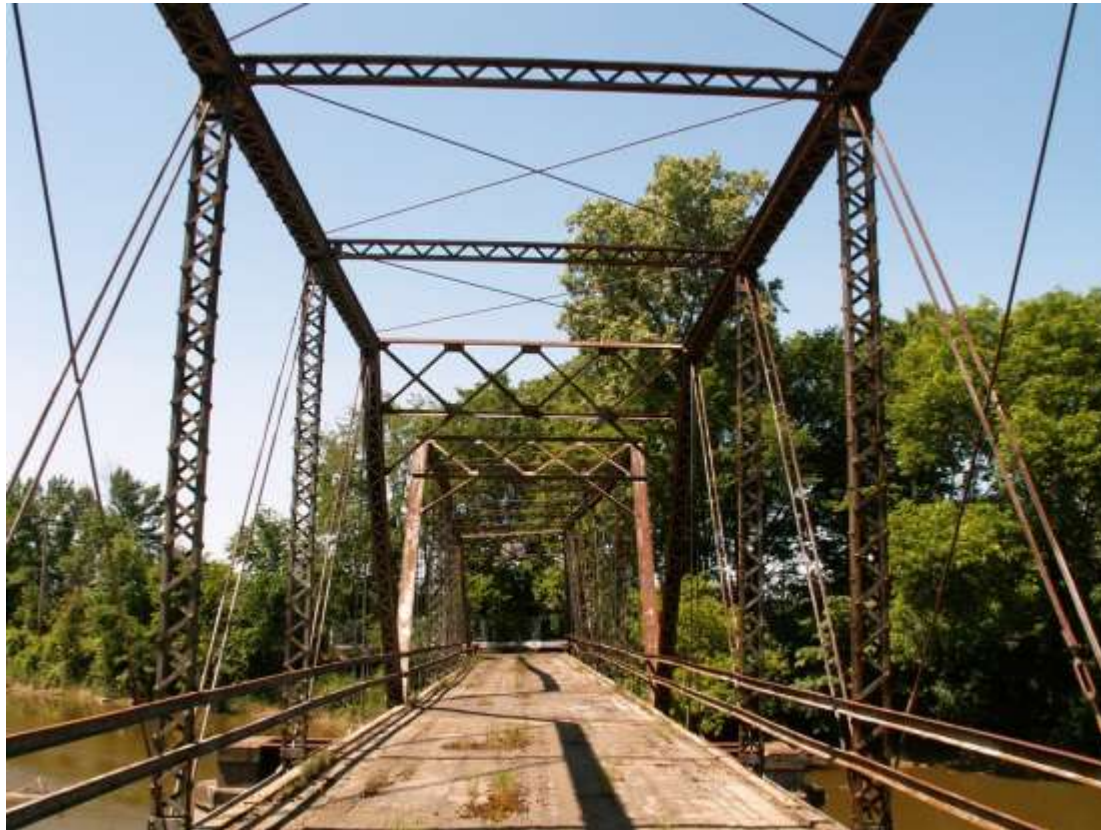
**Bridge before restoration. Due to failing pier, the spans were twisted slightly and at risk for eventual collapse.**

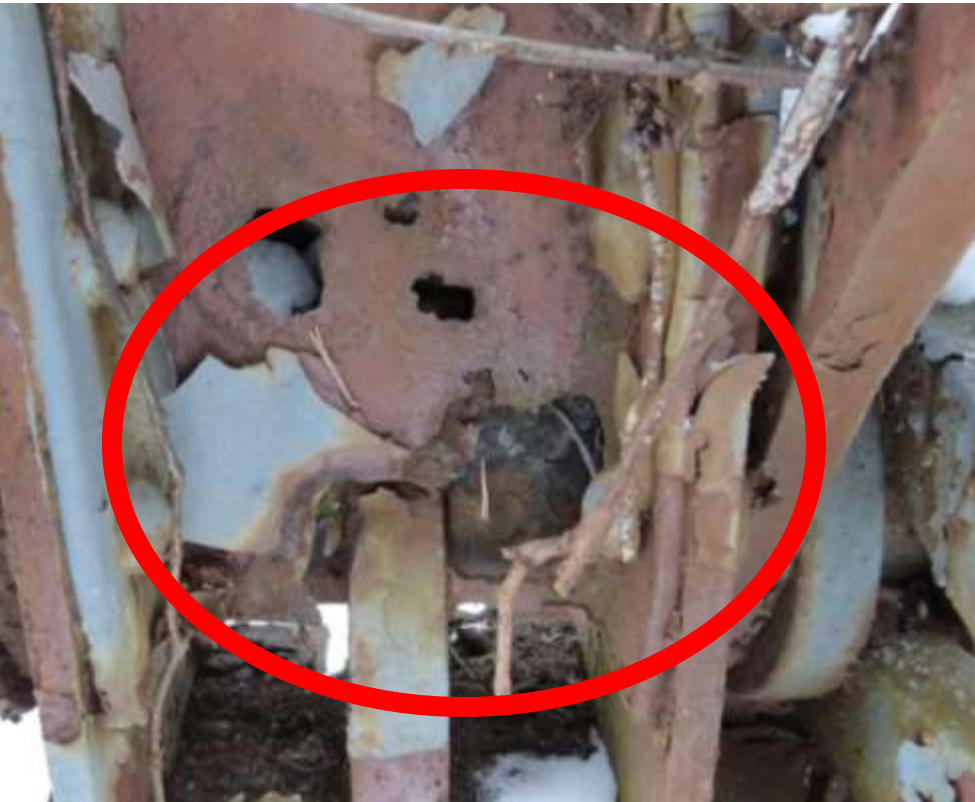
**Widespread areas of deterioration can be replicated.**

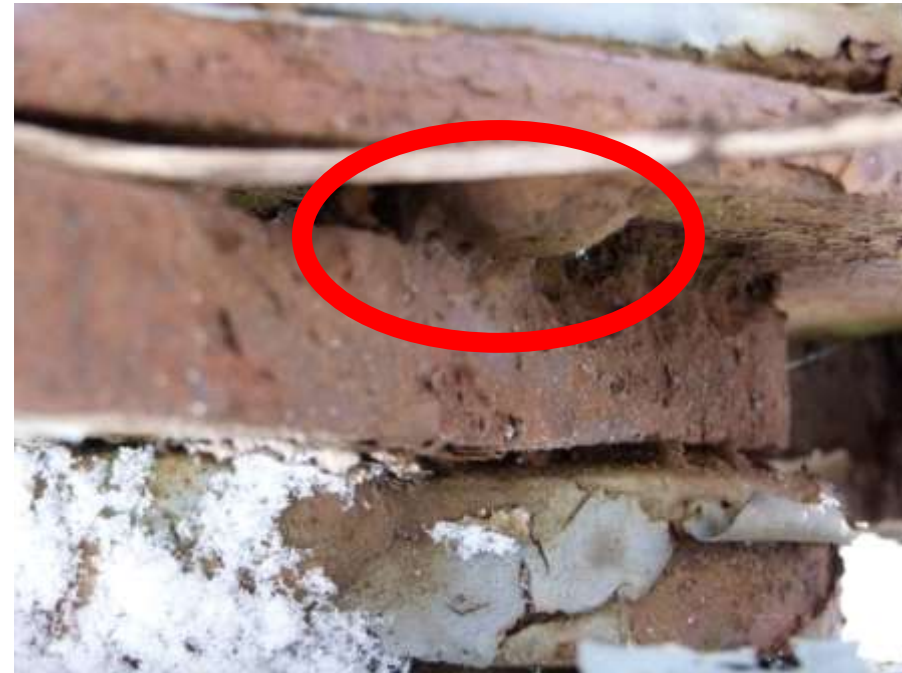
**Isolated or minor deterioration can be repaired.**

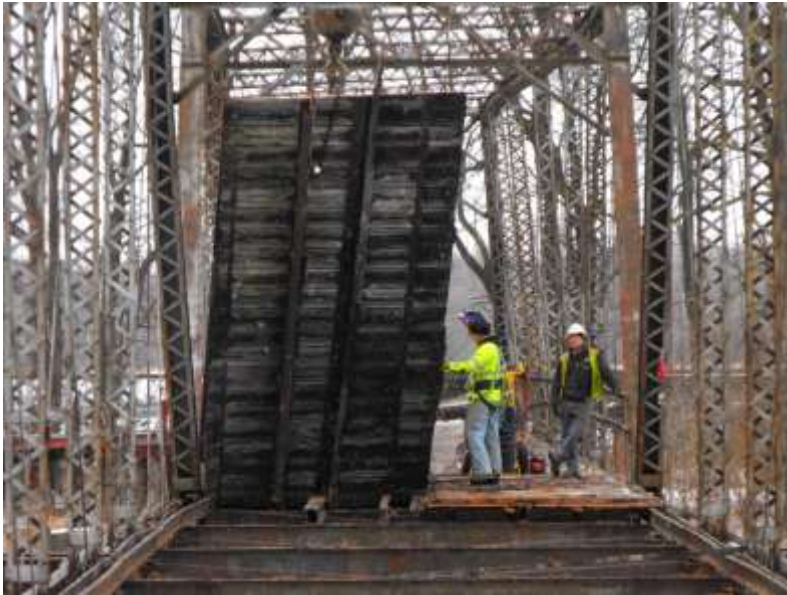
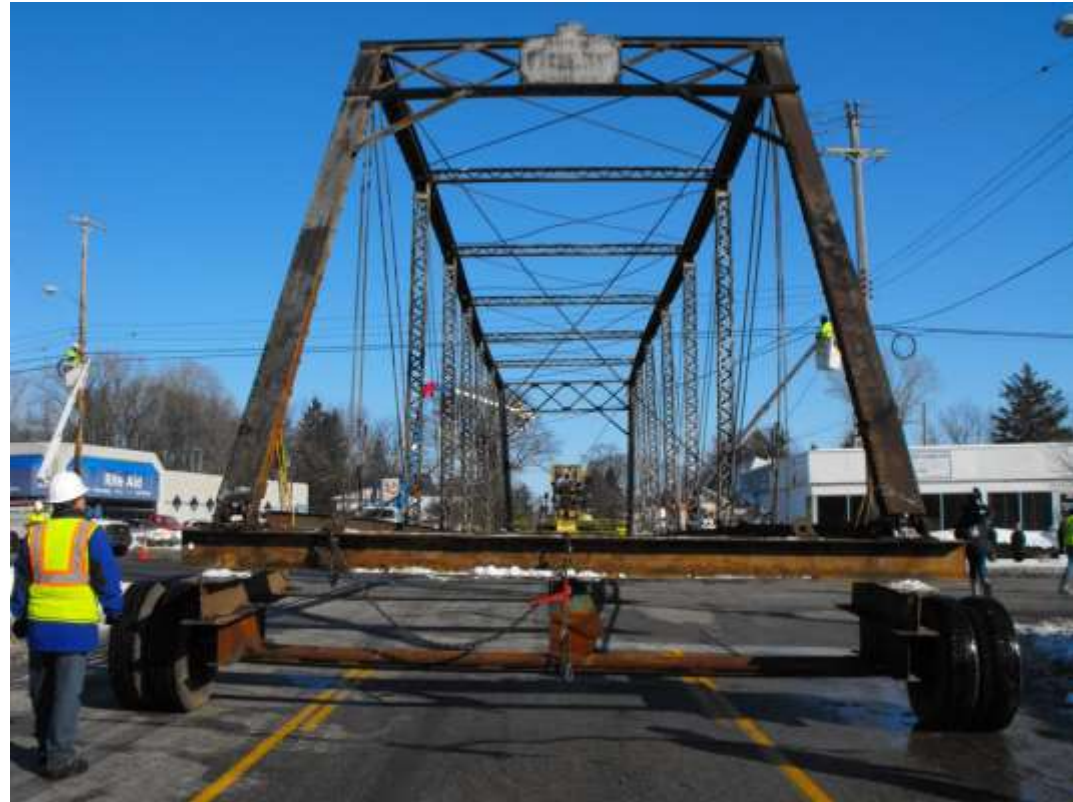
**After deck removal, truss was removed from the substructure with cranes, and rolled to a nearby site to be dismantled and shipped to Bach Steel.**

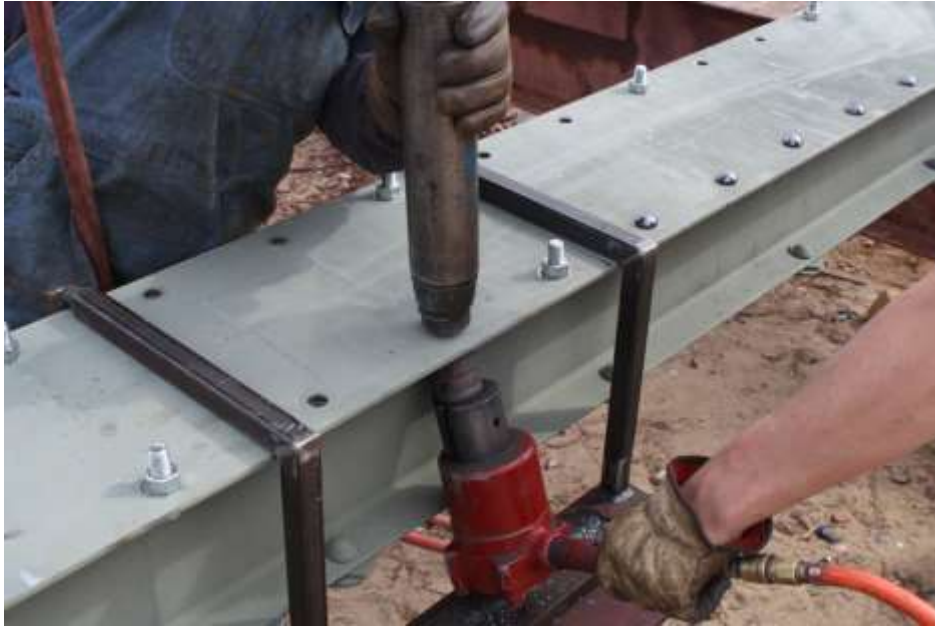
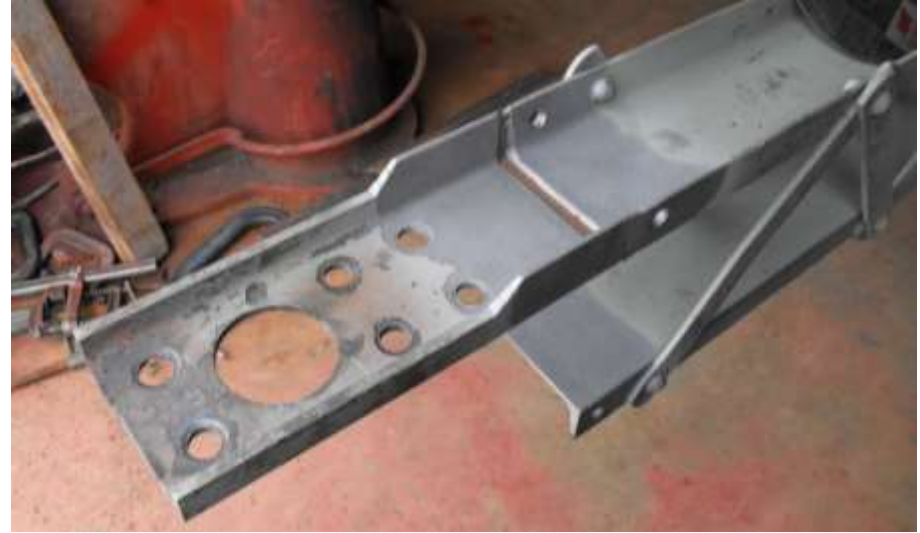
**Restoration of bridge parts at shop. Examples of work completed shown above. Replacing rivets with rivets during restoration is economical, reliable, and historically correct.**

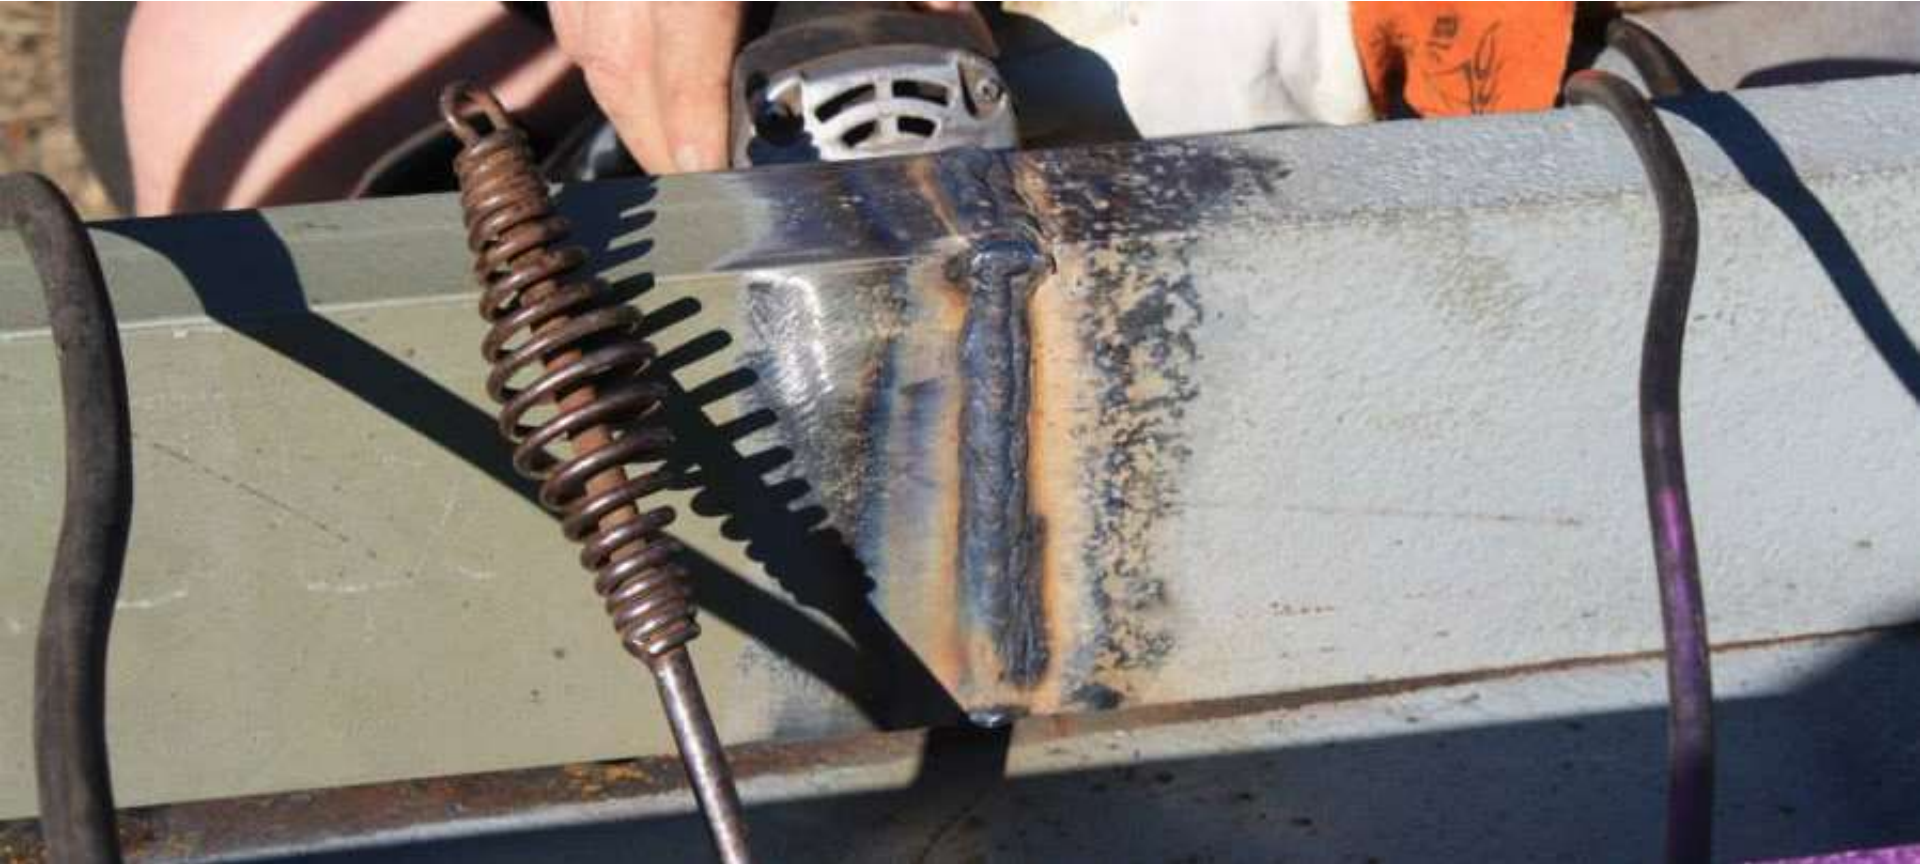
**There are a lot of misconceptions about welding wrought iron. The reality is that wrought iron can be reliably welded.**

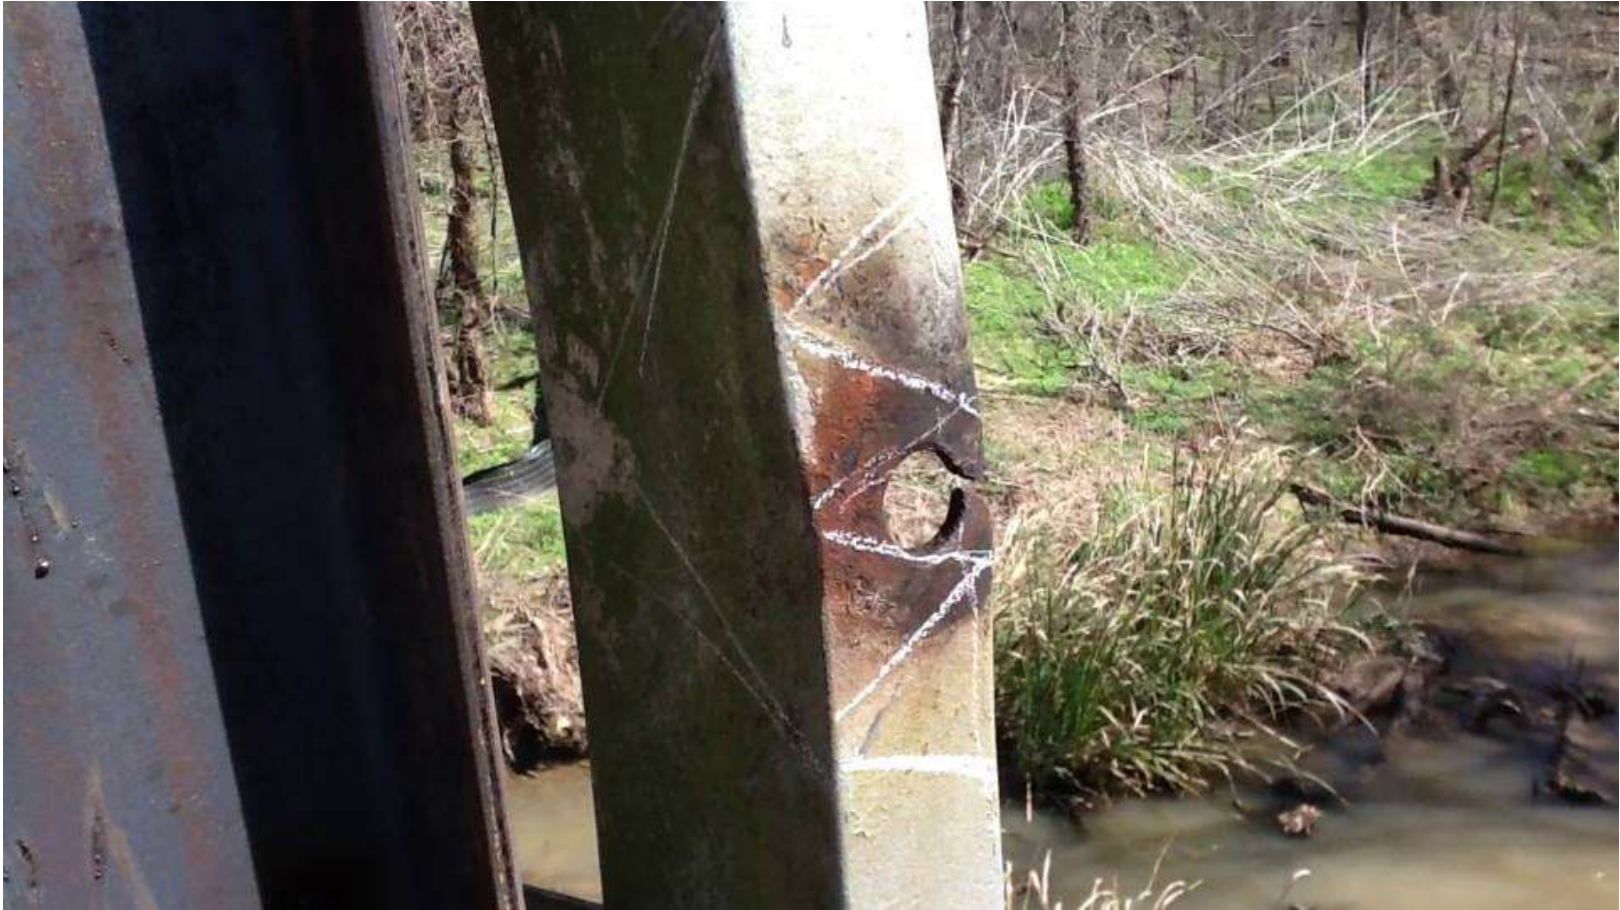
**Heat straightening can be done on historic truss bridges in a manner similar to that done for modern steel bridges.**

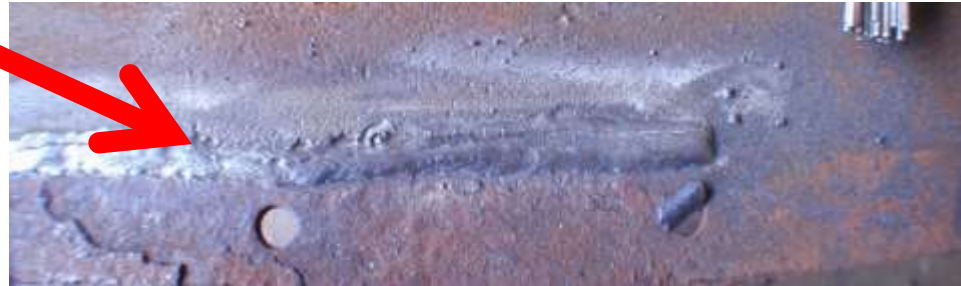
**Pad  
welding in  
progress.**

**Areas of section  
loss cleaned  
before repair**

**Isolated and moderate section loss can be repaired by pad welding. This applies to a variety of bridge parts including plates, beams, and eyebars.**

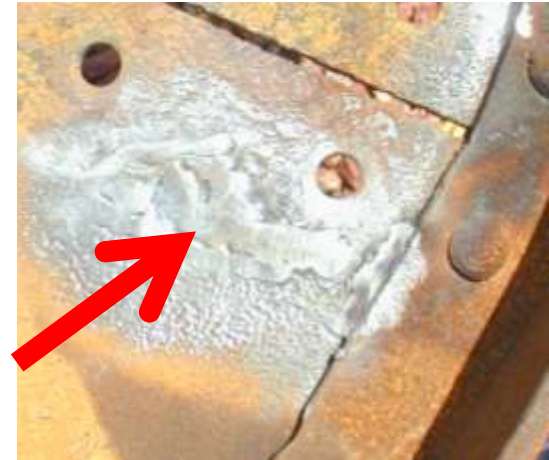
**Pad welding  
completed.**

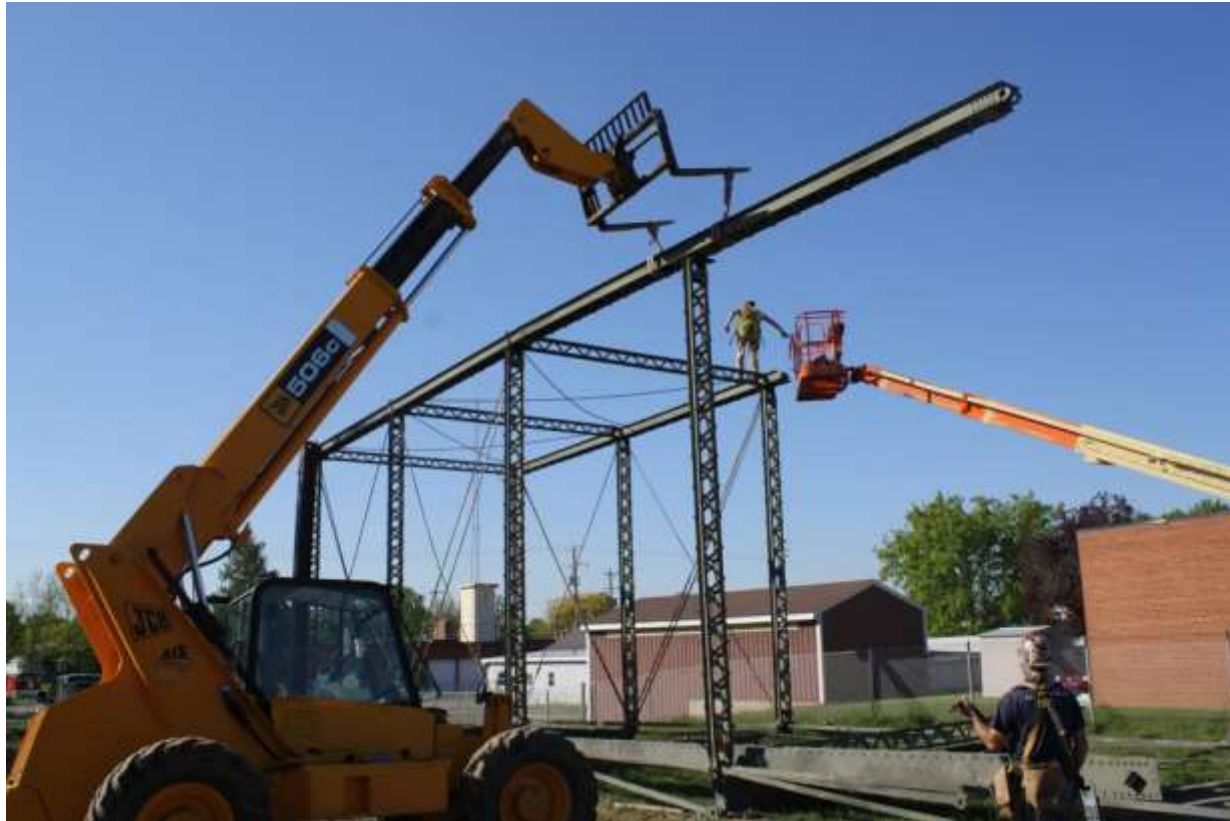
**Reassembly of the bridge on the ground a short distance  
away.**

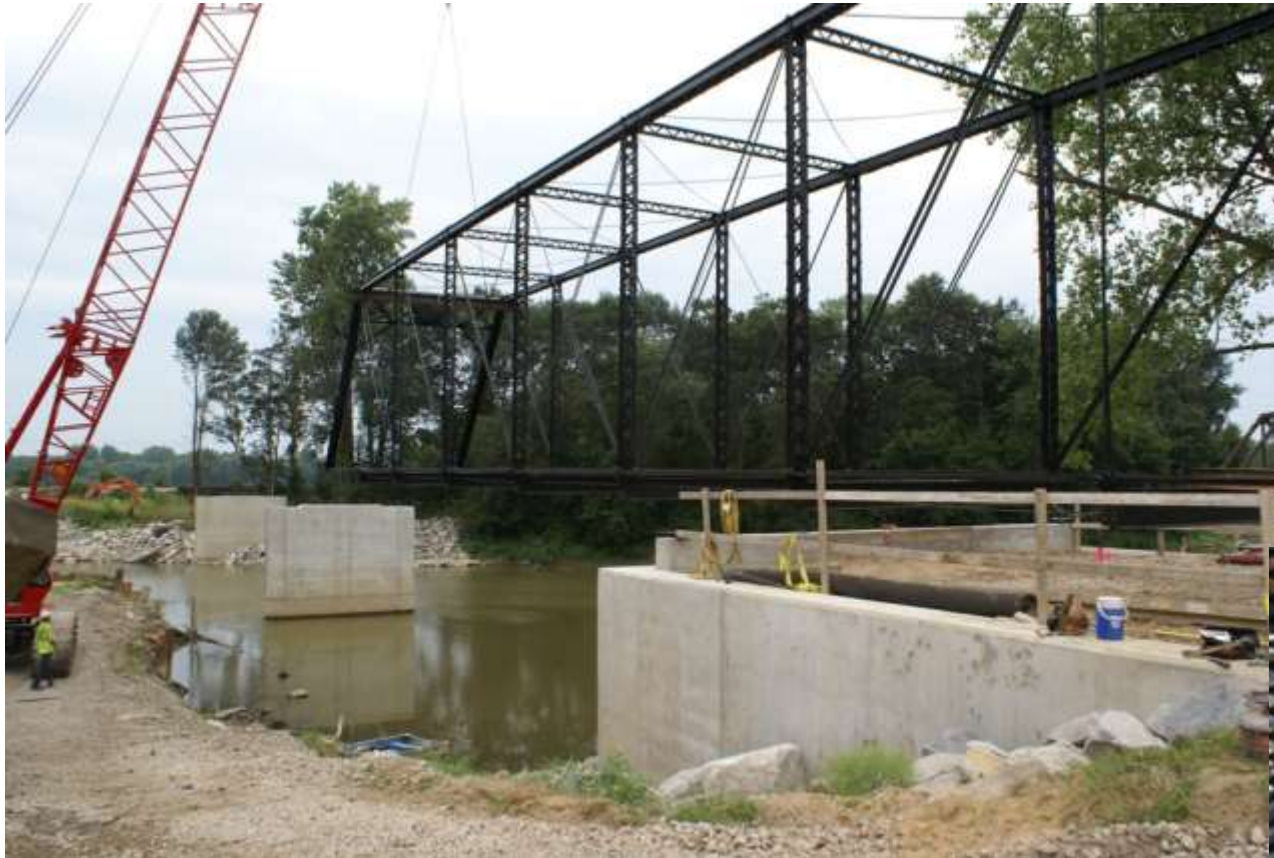
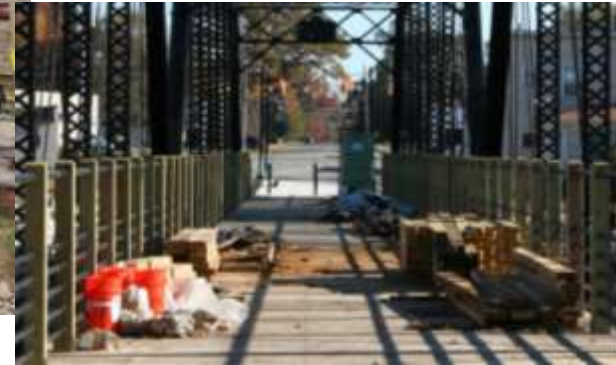
**Placing the assembled truss on new abutment and pier  
followed by deck installation.**

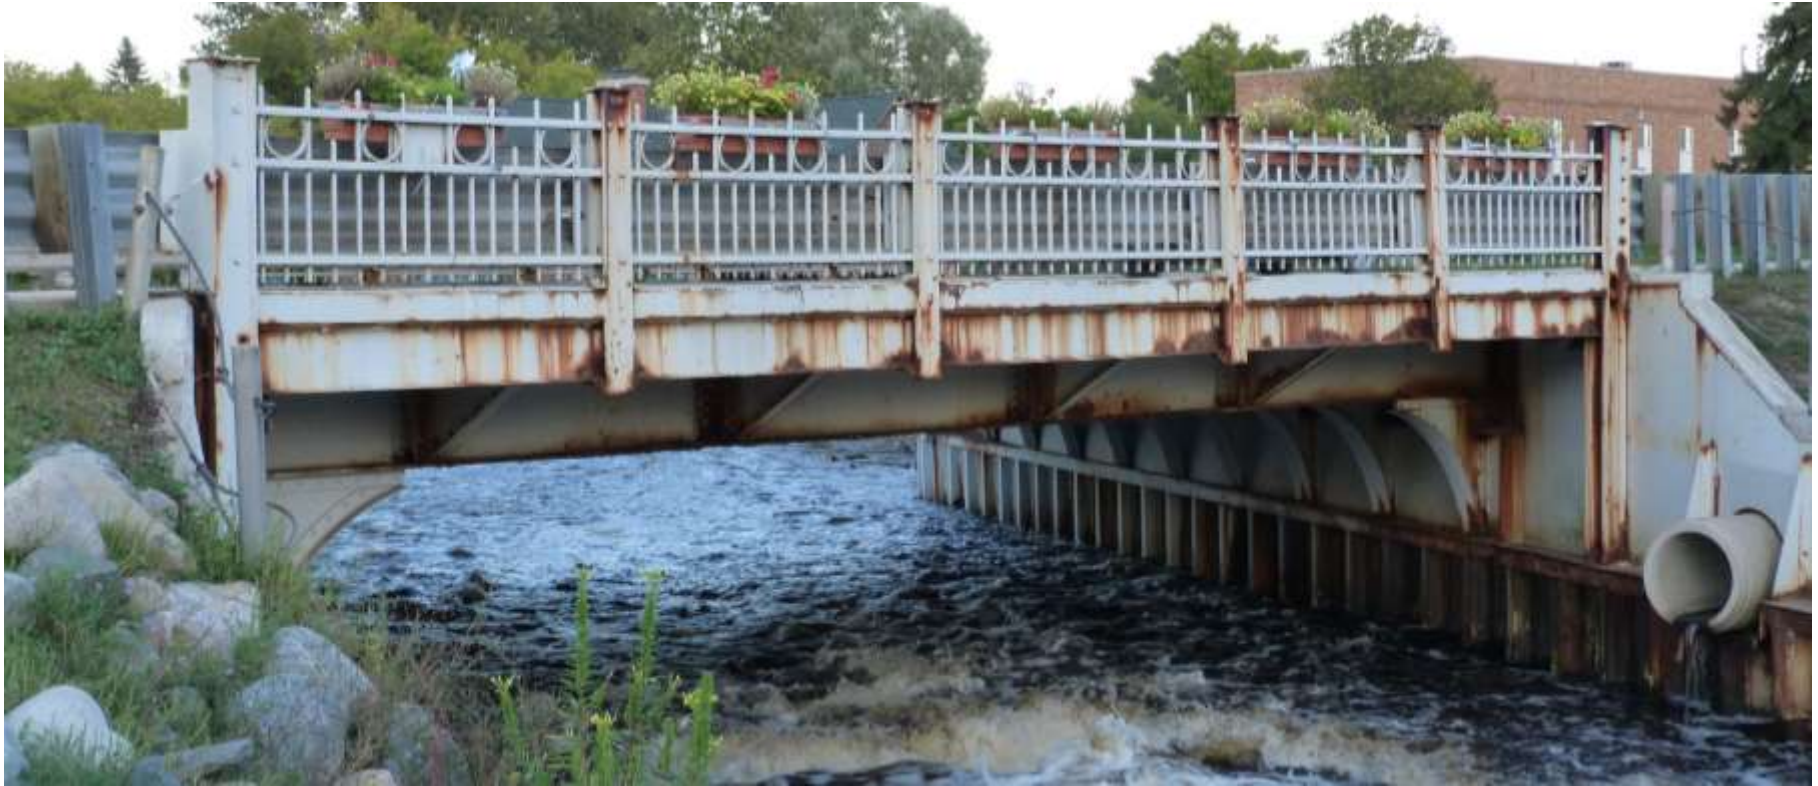
**M-72 Ausable River, Grayling, MI  
Rehabilitation of small riveted steel rigid-frame bridge on  
Business Loop 75 (M-72).**

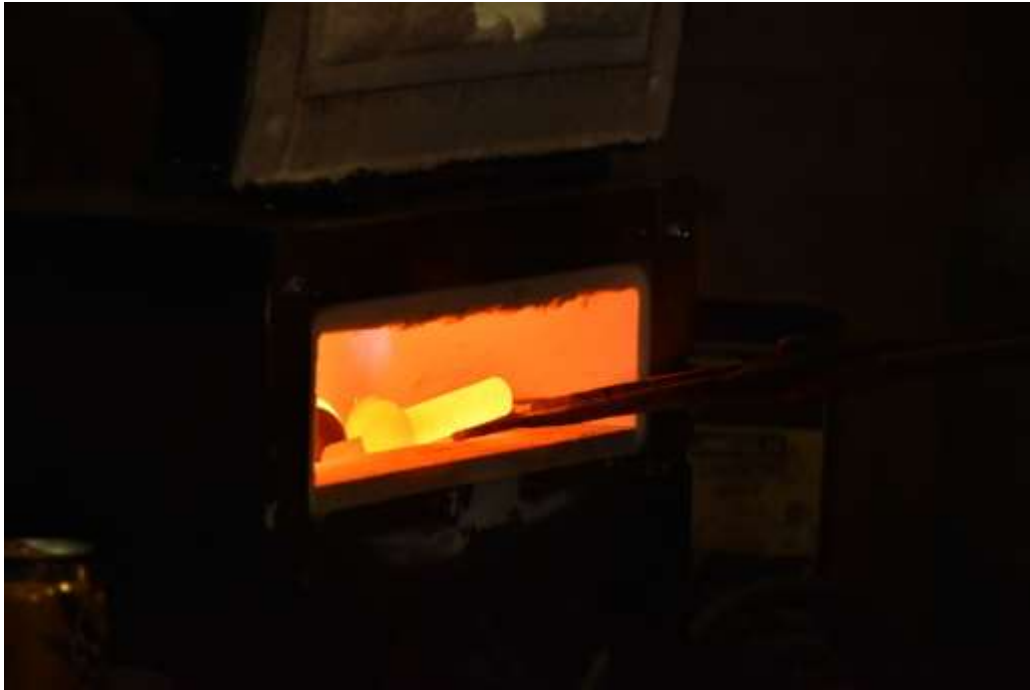
**M-72 Bridge Hot Riveting In The Shop**

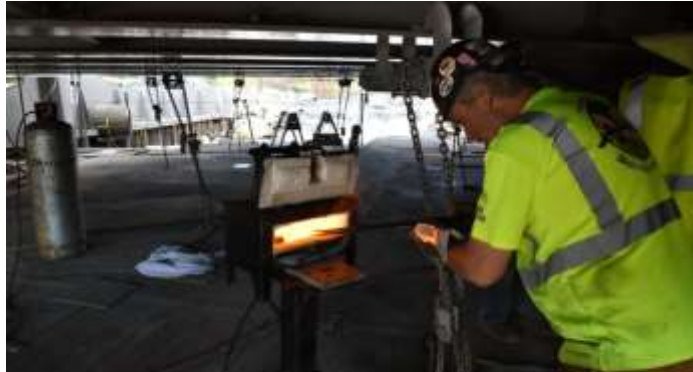
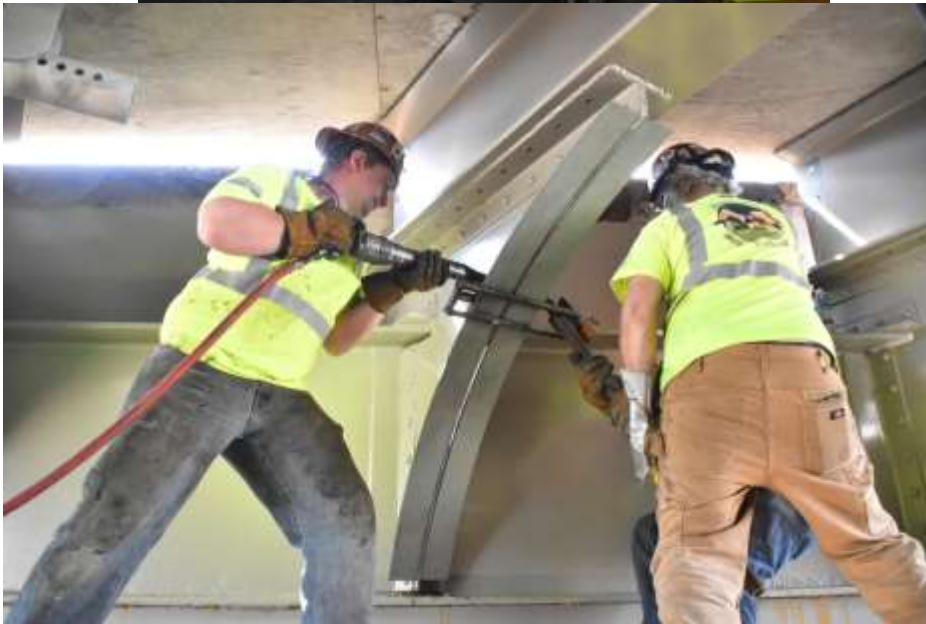
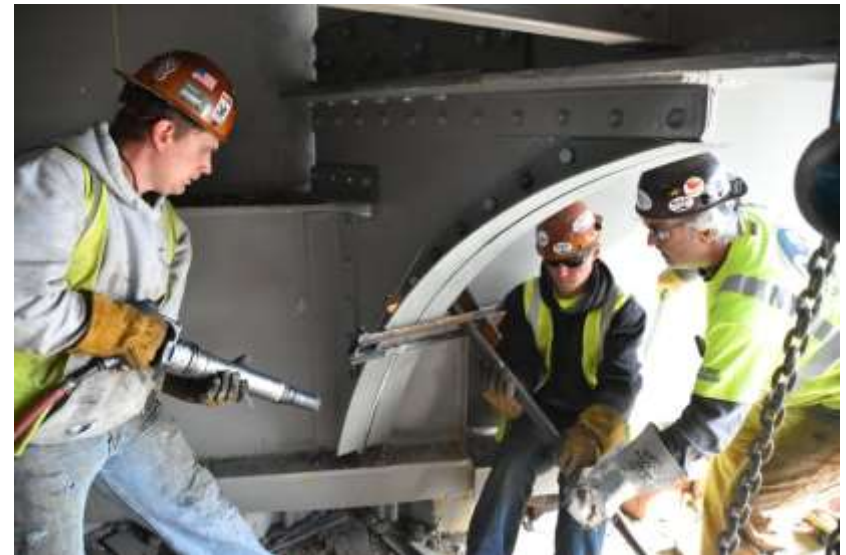
**M-72 Bridge Hot Riveting In The Field (Tight Locations)**

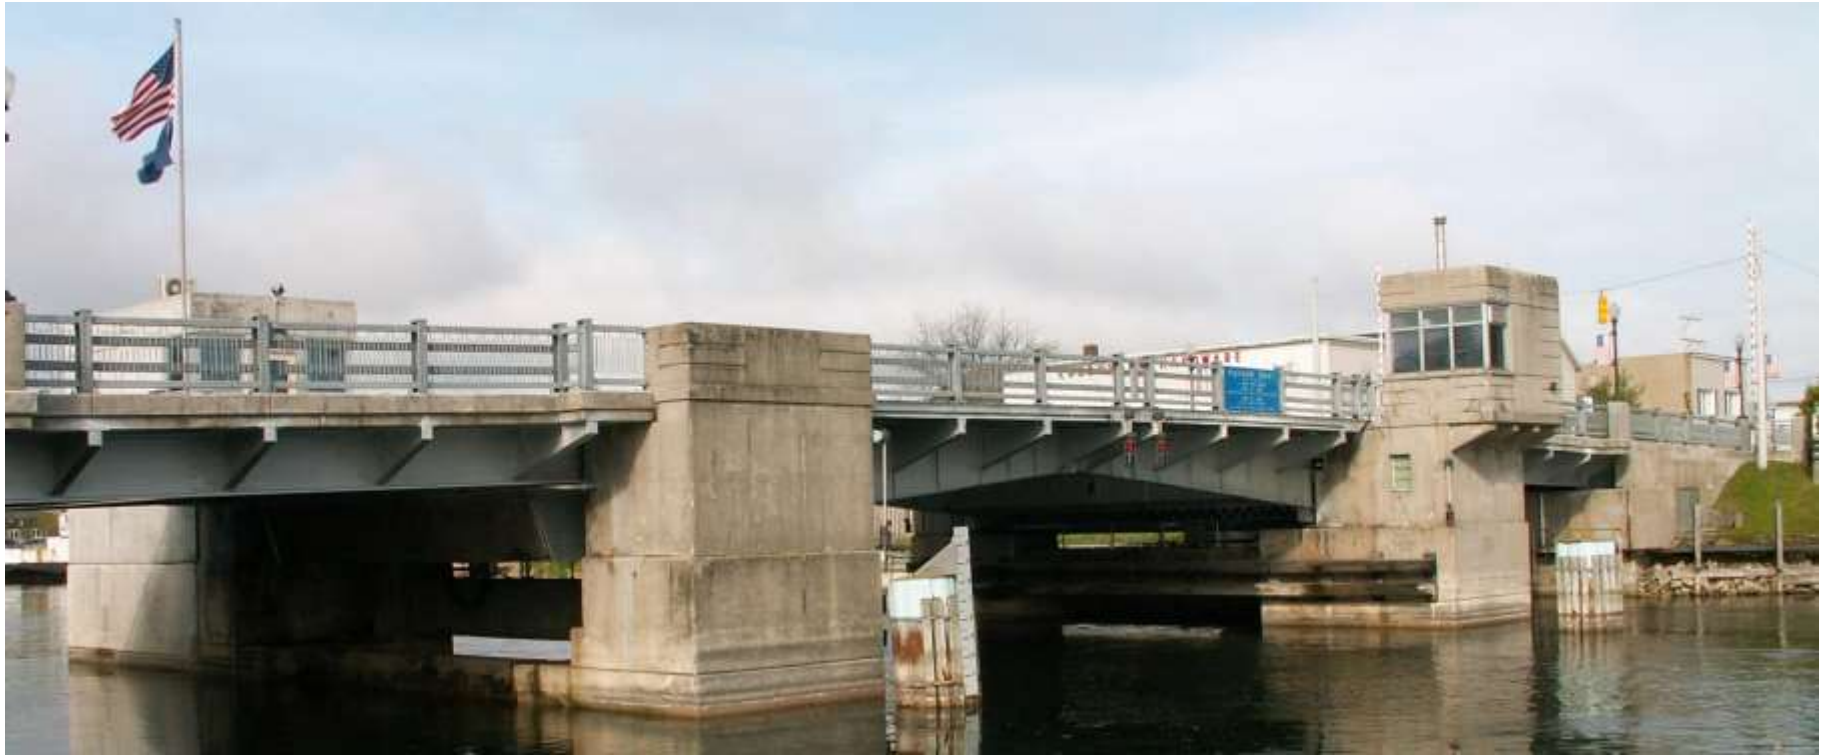
**US-23 Cheboygan River Bascule Bridge  
Rehabilitation of historic riveted bascule bridge on major US  
Highway.**
