# Evaluation of a Rectangular Rapid Flashing Beacon system at Belmont Ridge Road and W&OD Trail mid-block crosswalk

**Joe Kroboth, III, P.E., LS, PWLF**

Loudoun County, Virginia

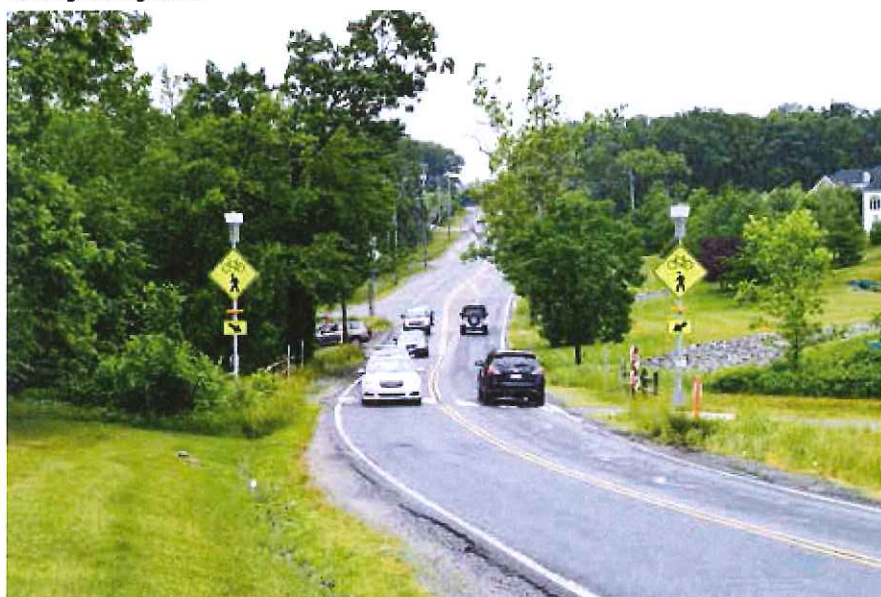
**Figure 1 – Belmont Ridge Road at the W&OD crossing looking north**

Belmont Ridge Road is a two-lane secondary road with a speed limit of 45 mph that runs generally in a north/south direction. In 2013, an operational analysis of Belmont Ridge Road revealed a regular level of service D and average daily traffic of nearly 18,000 vpd. Approximately six-percent of the traffic composition is heavy trucks. The geometry of Belmont Ridge Road consists of downhill grades on both the north and south approaches to the crossing. The northbound approach has a horizontal curve that decreases the viewing distance of the crossing, as opposed to the southbound approach, which has a relatively straight line of sight to the crossing.

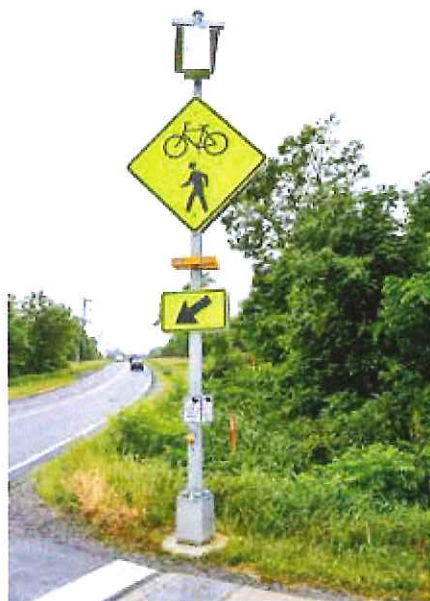
Figure 2 – RRFB and warning signs

The RRFB system includes two poles located on the east and west side of Belmont Ridge Road crosswalk. At the crosswalk, each pole is mounted with double-sided W11-15 fluorescent yellow-green bicycle/pedestrian signs; W16-7P arrow signs; and high-performance SB345 RRFBs.

In addition, each pole has an SC315 network controller, a solar panel to power the network controller for wireless transmission of the RRFBs on the upstream poles. The pressure-activated push button is compliant with the Americans with Disabilities Act (ADA) and MUTCD.

When activated, the RRFB emits rapid, alternating amber LED bursts of light to warn motorists that trail users are at the crossing. According to manufacturer's specifications, the pulses of light can be seen during daylight and nighttime at distances >1,000 feet and in certain situations >1 mile. Upon activation, the LED

light stays on for 20 seconds, a time established by engineering analysis based on the crossing geometry and typical walking speed.
