# Surviving Pearl Harbor

Corrosion damage mitigation and new coating systems restore the Harbor Control Tower.

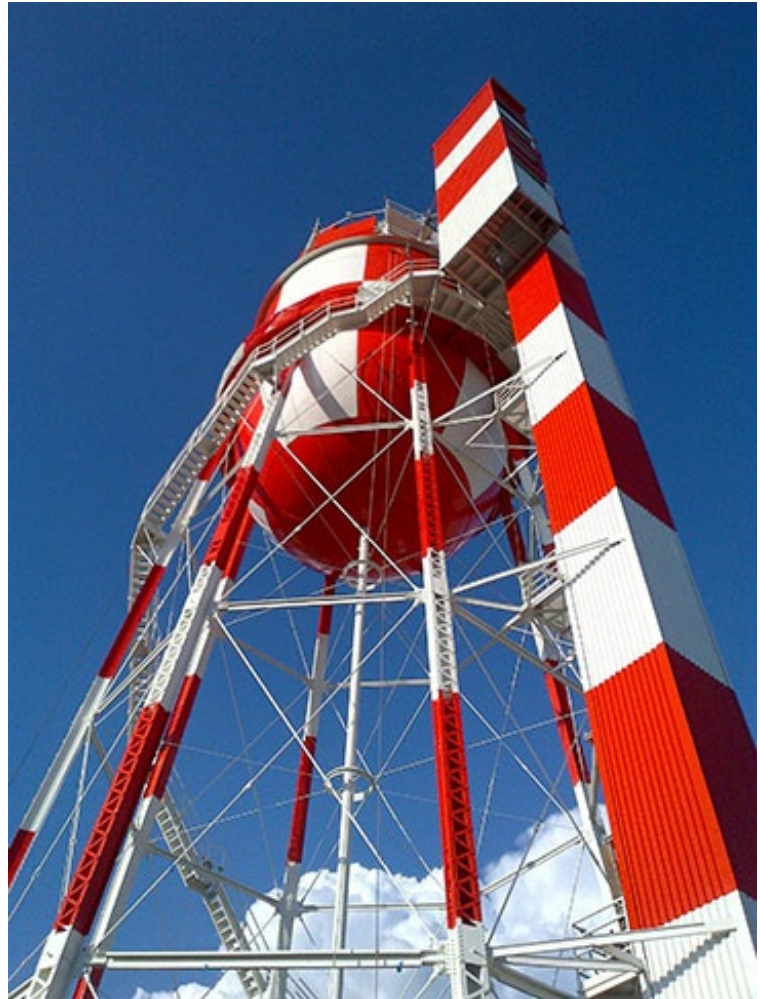
The Harbor Control Tower was restored to its original orange and white checkerboard pattern. Photo: Sherwin-Williams Protective and Marine Coatings

Zinc Clad III HS, a polyamide epoxy, zinc-rich coating, was used for corrosion prevention as the base coat. To ensure protection of edges, corners, and welds, Macropoxy 646, a high-solids, fast-cure epoxy, was applied as the intermediate coat. The top coat, Fluorokem HS, played the most crucial role in aesthetically repairing the tower.

"The biggest challenge during the application process was aligning the orange and white checkerboard pattern in every direction," Schmid said. "For the final coat, we spent a lot of time measuring out each square with a laser."
