Restoring Stained Glass Windows Oxford Presbyterian Church Seminary Building

Stained Glass Window Restoration...*the process*

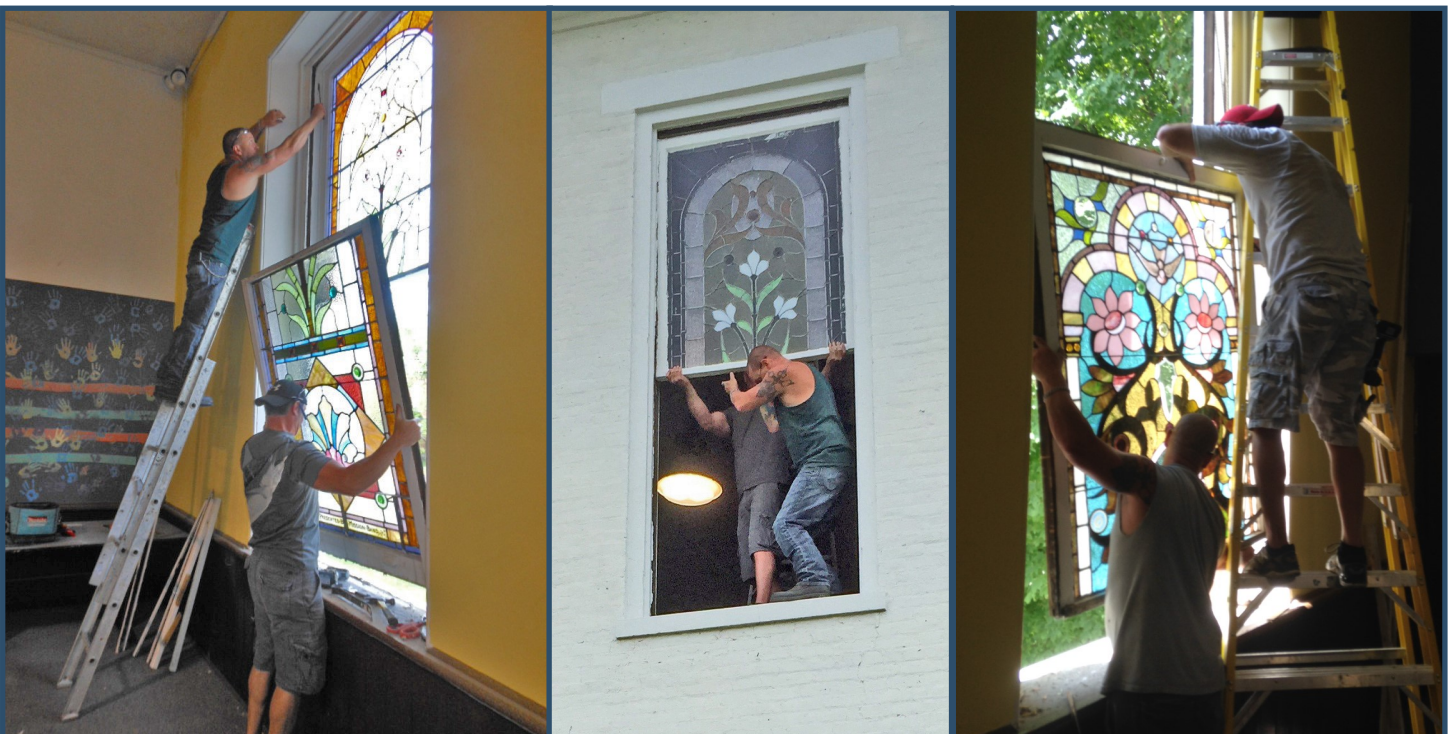
Each window is carefully removed from its frame by a team of removal specialists and transported to the Middletown studios where the detailed work of restoration will proceed. The schedule for this project is to remove and restore two windows at a time. Once those windows are completed and replaced, the restoration of two additional windows is addressed.

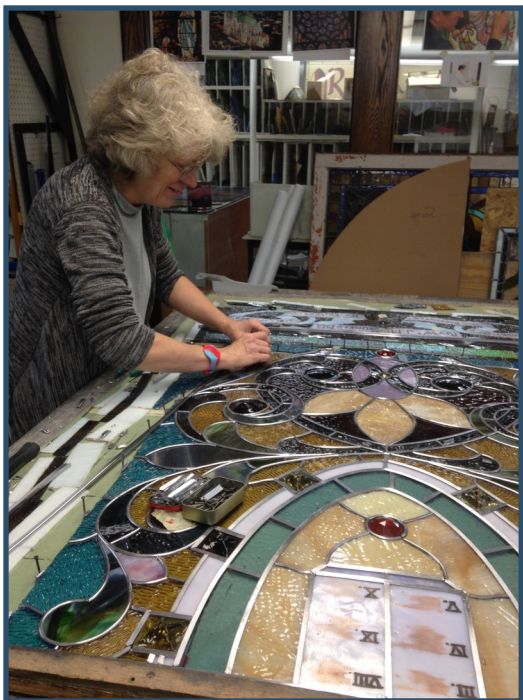
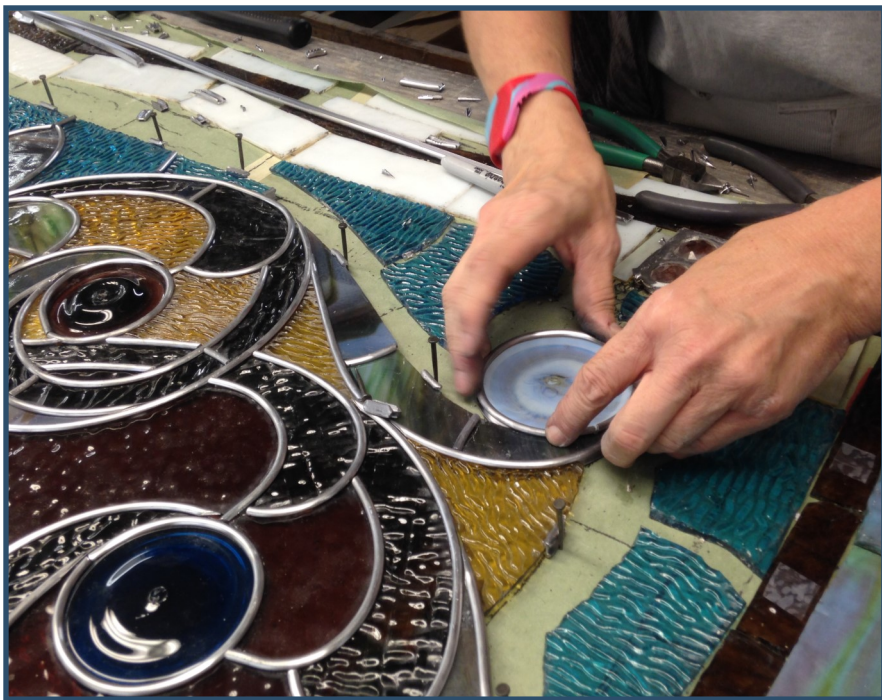
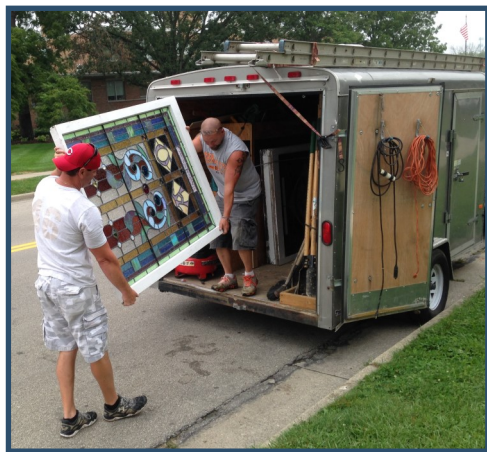
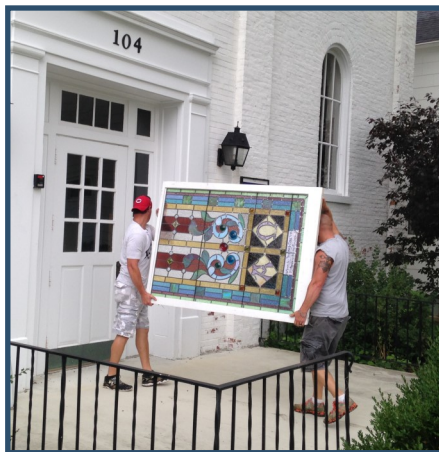
The studio restoration work is very detailed. The first task to be addressed is to make a full sized rubbing of the window which becomes a template for glass placement. The entire window is disassembled by removing each piece of glass from the lead came which holds the pieces together. The old lead came is discarded to be replaced by new leading. Pieces of glass are individually cleaned and glass that is broken or cracked is replaced. Pieces are reassembled using new lead came. Once reassembled, the lead came is soldered and putty is applied to all joints. The window is cleaned and wood frames are repaired as necessary, then primed and painted.

After the restoration is completed the windows are returned to the Seminary Building. The windows are re-installed and a covering of tempered glass is added to the exterior of the window for maximum protection. The next two windows are then removed for transport to the studio and the process continues.
