A NETCO COIR ENVELOPE PROJECT

Erosion Control at Cranston, RI's Stillhouse Cove

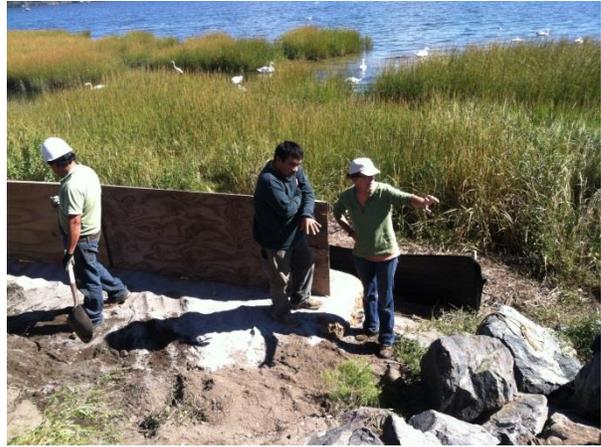
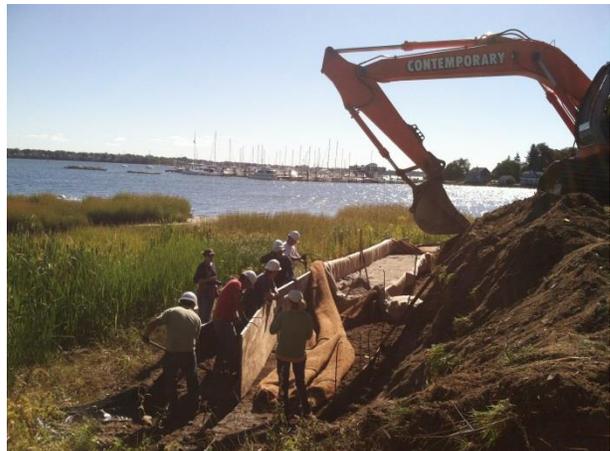
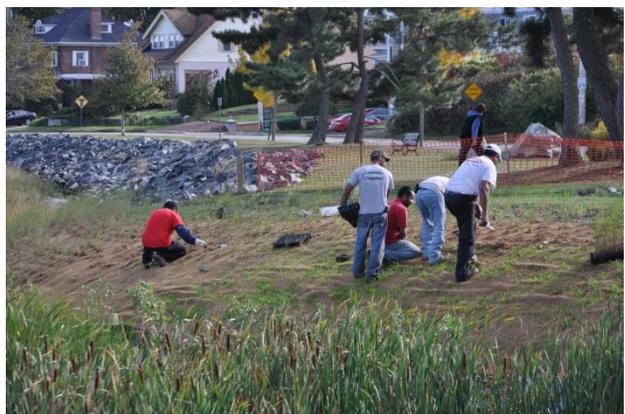
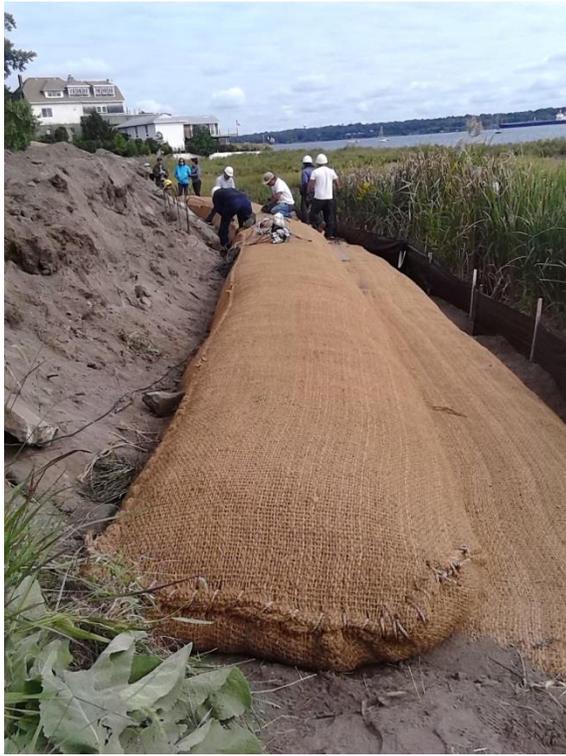
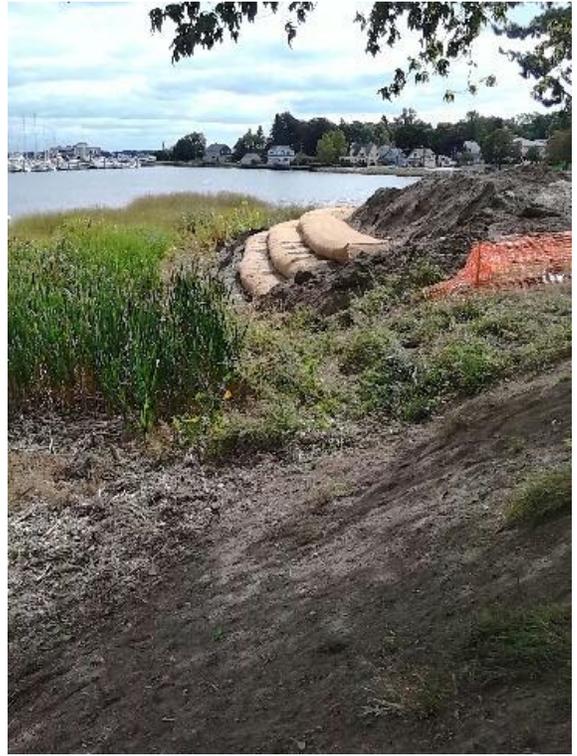
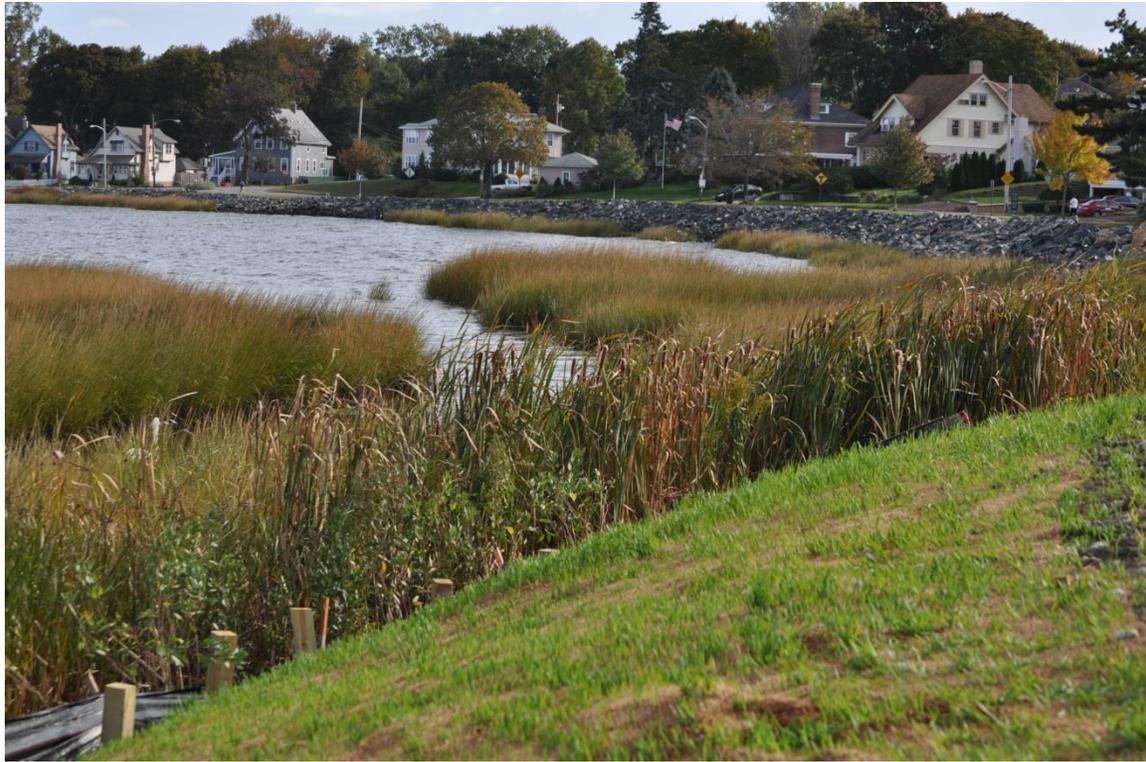
An excavator was used to carve a slope out of the bank, and then three coir envelope terraces were installed and were covered with the soil excavated from the bank. Erosion control mats were then installed over the face of the slope to stabilize the cover material until the vegetation could take hold.

NETCO teamed up with Contemporary Landscaping, a local contractor to complete the work. The bank was carved back to create a gentle slope that will dissipate future wave energy and NETCO coir envelopes, were installed to protect the slope from future storms.

Once the bank was regraded, a variety of native grasses were planted to act as a buffer between the park and the salt marsh, and to stabilize the bank. NETCO, along with volunteers from EWPA, students from Johnson & Wales University, and Save The Bay staff and interns, installed 6,500 plants along the cove in just one week.
