Revolutionizing Renovation – one building at a time

It began with the Carlyle Towers, a 55-year-old multi-family apartment building in West Caldwell, New Jersey. The property owner, David Legow, was concerned about rising energy costs and was hoping to find practical solutions to improving the energy efficiency of the 100-unit building.

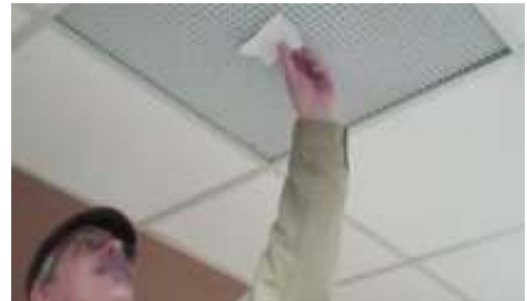
The next time you're in a public building, locate the exhaust vent (often on the ceiling or along the walls in bathrooms) and simply place a piece of tissue paper over the vent. If the tissue sticks – consider it a pass. But if the tissue falls to the floor, you can assume that the building is under ventilated. If the exhaust rate is too low to even hold up a piece of tissue, it is certainly too low to adequately replenish the air. It's a clear indication that the building's ductwork is leaking so much air that the exhaust fans cannot adequately do their job.
