# SWIVEL SNAPHOOK INSPECTION NOTIFICATION

**Inspection notice for GFP products featuring a possible unsafe condition due to a supplier defect in a specific style of swivel snaphook supplied to Guardian between 8/26/2011 and 6/25/2012**

Date: 6/26/2012

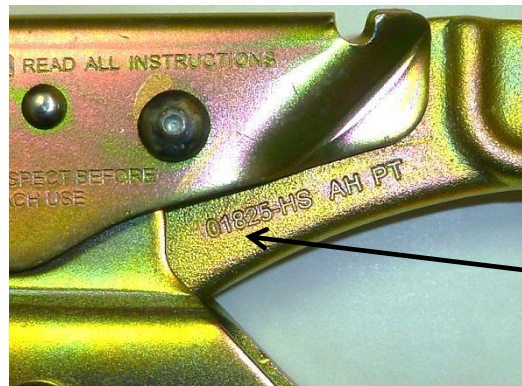
Marked with part # 01825-HS or 01826-HS on the hook body

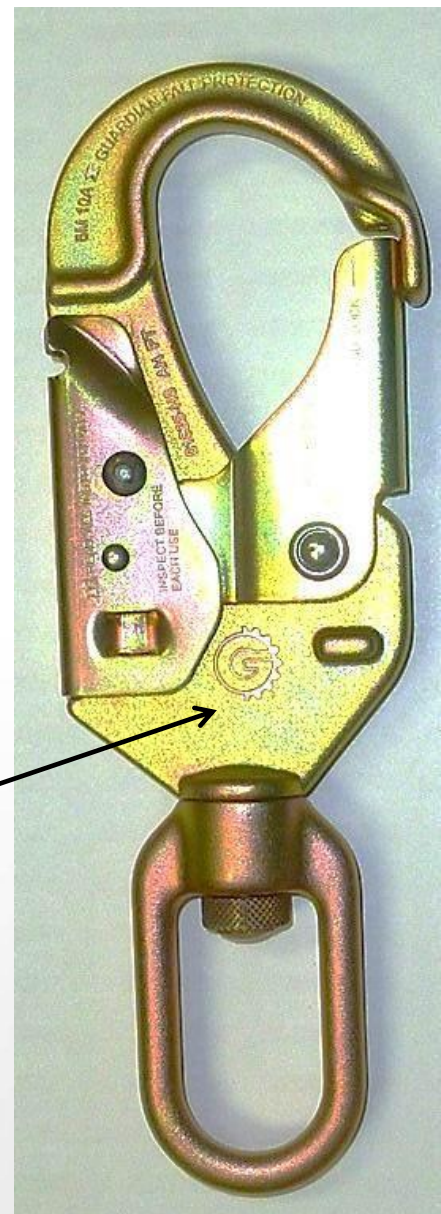
Full photo of the potentially defective swivel snaphook.

Marked with Guardian logo at hook base
