C&W UPDATE: PROGRESS ON THE ELEPHANT VAN/PLAY CARRIAGE

Work on the scenery/elephant van No. 4601, which is currently undergoing restoration in the carriage works courtesy of a Museum Resilience Fund provided by Arts Council England (ACE), is progressing apace. The project started in April last year, and we have just two years to complete it.

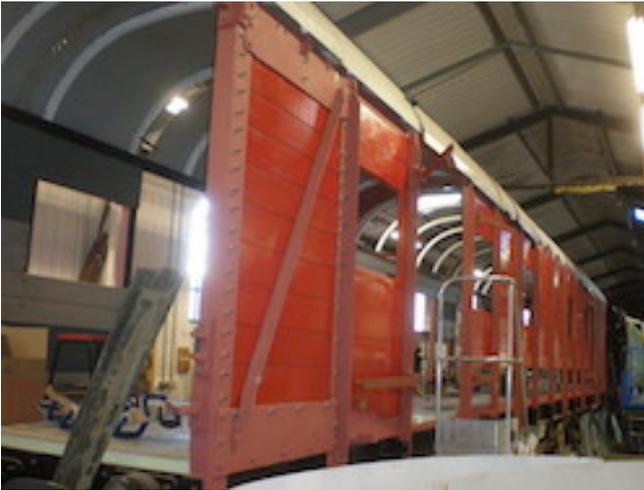
The van suffered somewhat as a store for the S&T Department, sitting in the elements since 1981. After it was identified as the most suitable candidate for a play carriage, the cable drums it contained were removed and it was shunted into the work area of the carriage shed.

After stripping components, apart from the floor, the metal frame was grit-blasted down the yard. Once back in the shed, the old double-planked floor was removed and the lower thick floorboards replaced with new softwood ones, painted for protection. The side planking was originally a mixture of hardwood and softwood boards, but it is being completely replaced with hardwood (utile) planks, apart from some original hardwood ones which span the whole length between the double doors on each side, which have been repaired as it is nearly impossible to obtain timber of this length now.

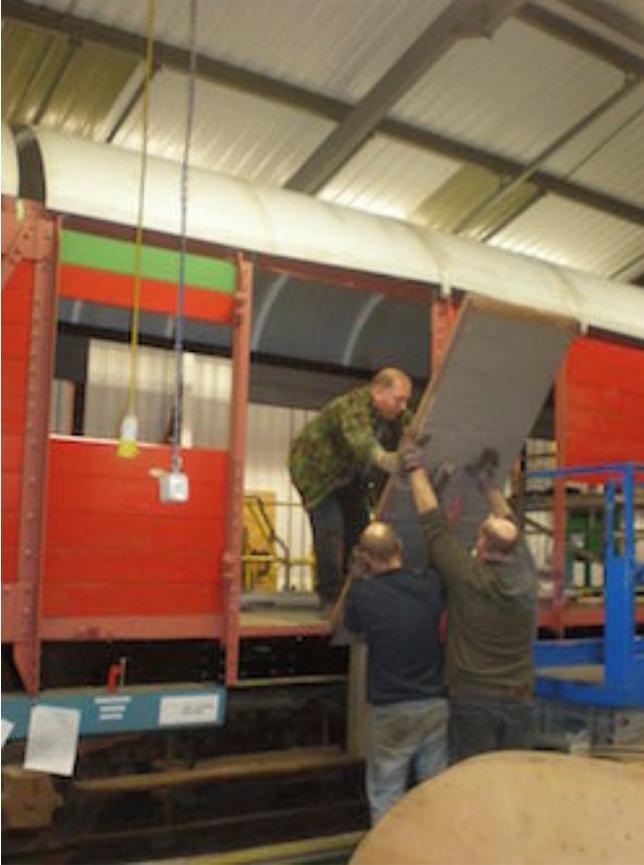
The side planking is trial-fitted and then removed section by section to allow the painting to top coat of the outer faces and edges. The sections are then reassembled on the van for the final time. New sidelight frames are being produced and fitted as well.

Where long boards have been replaced with new, two boards have been half-lapped to make boards of the correct length. The use of hardwood for the exterior should mean that the van will last a good few years before having to have any attention as it will be living outside.

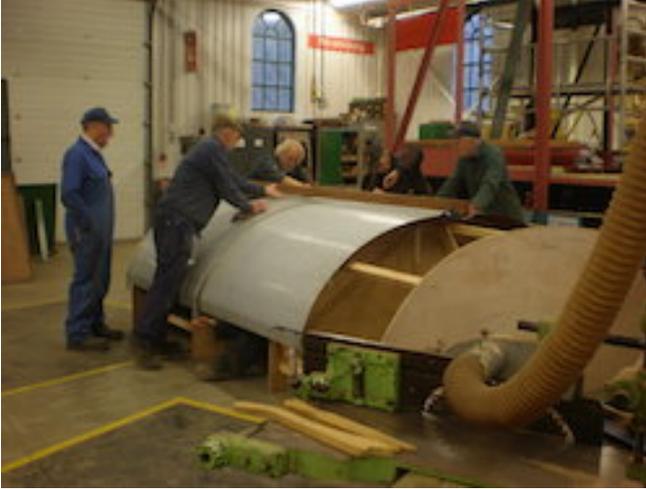
After some discussion, it was decided to use stainless steel button head socket bolts and nylon insert nuts as fixings. Half of the cover straps were drilled by the contractor so that they could be used as templates for drilling the sheets and the lower straps. The drilling was done at floor level using a couple of jigs to support the sheets side by side. The sheets were then lifted on to the roof of the van and checked for fit. Only the centre sheet has been drilled to locate it on to the wooden roof sticks, which are all new utile ones. The sheets have been marked for position of the screws for the roof sticks, then moved to one side to allow them to be drilled from underneath.

The roof has posed the biggest challenge, and we haven't tackled anything quite like this before in the C&W. The original mild steel roof sheets were cut into pieces and removed prior to grit-blasting and have been replaced by zintec sheets which had to be cut and rolled by a contractor due to their size. Originally, these sheets were riveted together with cover straps above and below the sheet joins.

The roof sheets are being removed a couple at a time for countersinking of the fixing down screw holes and for a rigorous system of painting of the zintec including etching with mordant solution which will hopefully ensure that the paint stays on them. The same painting regime is being applied to the cover straps. One set of end and one set of side double doors have been kept intact as patterns, and work progresses on the production of the first two sets of each. Once again, the planking for these is the hardwood utile.
