# Shop Solutions

June 2016

Originally published in Engine Builder Magazine, June, 2016

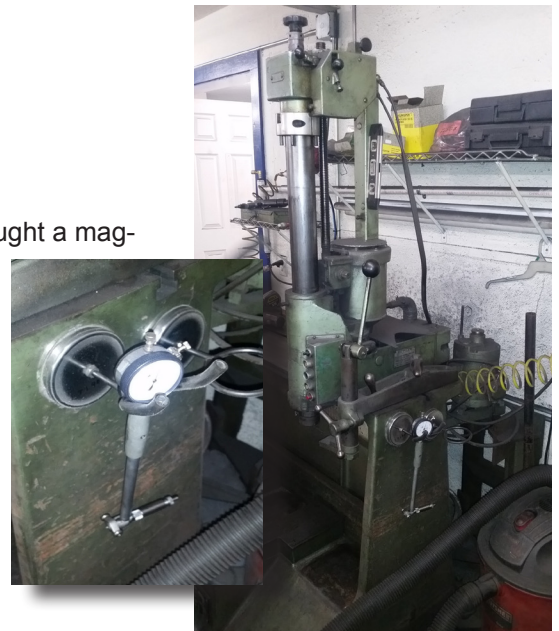
Boring Bar Stands don't have any place for holding your dial bore gauge. I bought a magnetic spay gun older from a paint and body shop supply store. I stuck it on my stand as you can see in the picture and now that gauge is right where I want it. This can be useful on many machines for holding additional tooling where you need it.

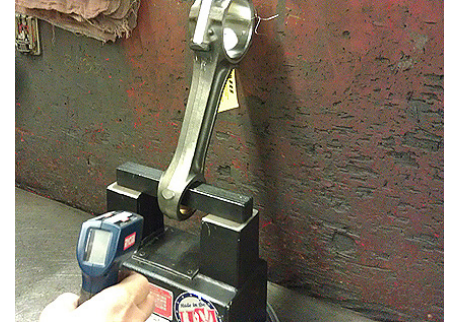
Pin Bushings require about the same amount of interference fit as a piston pin. The same rod heater you use to fit pins can be useful with certain pin bushings. Tapered rods can be very difficult to remove and install bushings in and usually require some custom made or special tooling. By heating the small end of the connecting rod in your rod heater you can expand the rod enough to make removal easy with drift, socket or piece of rod without hurting the rod bore.

Installing tapered bushings is just as difficult and they're often damaged during installation. By heating your rod end, starting the bushing is much easier and less likely to damage the rod or the bushing.
