8/4/15

UPDATE

Field Advisory - 3121 Unloading Adapter and L7579 Filler Valve

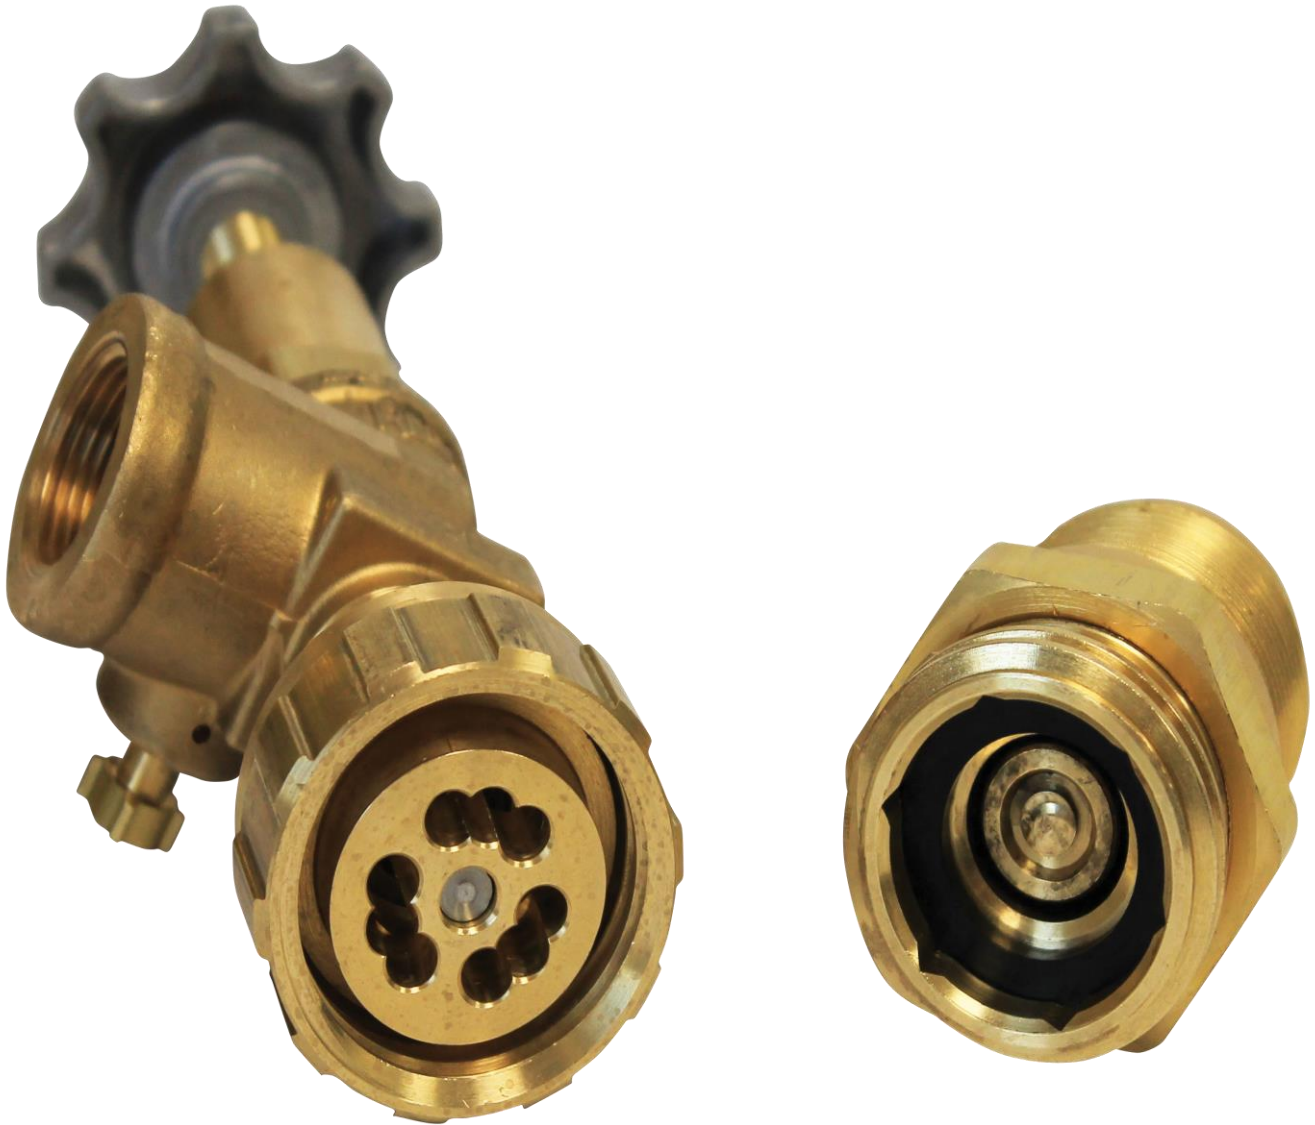
3121 Adapter

RegO engineering has confirmed that the 3121 unloading adapter ***does not have an issue*** regarding the use with low emission filler valve L7579. Engineering found that the 3121 adapter when assembled by RegO requires that the handwheel be rotated in the clockwise (Close) direction and to verify that the stem is flush or 1/4" recessed (see photos attached). The stem is then rotated counter clockwise (Open) direction to verify that the stem extends a minimum of .875". Any valve not meeting this assembly process is cause for rejection by RegO.

(In Closed Position)

Operational Note: Failure to ensure that the 3121 unloading valve in in the full closed position (stem not flush or recessed) prior to connection to any filler valve could cause a possible release of product.

We advise you to immediately check your inventor of 3121 unloading adapters to ensure they meet the above specifications. Please advise Ed Miller with any 3121 valves not opening and closing properly for return.

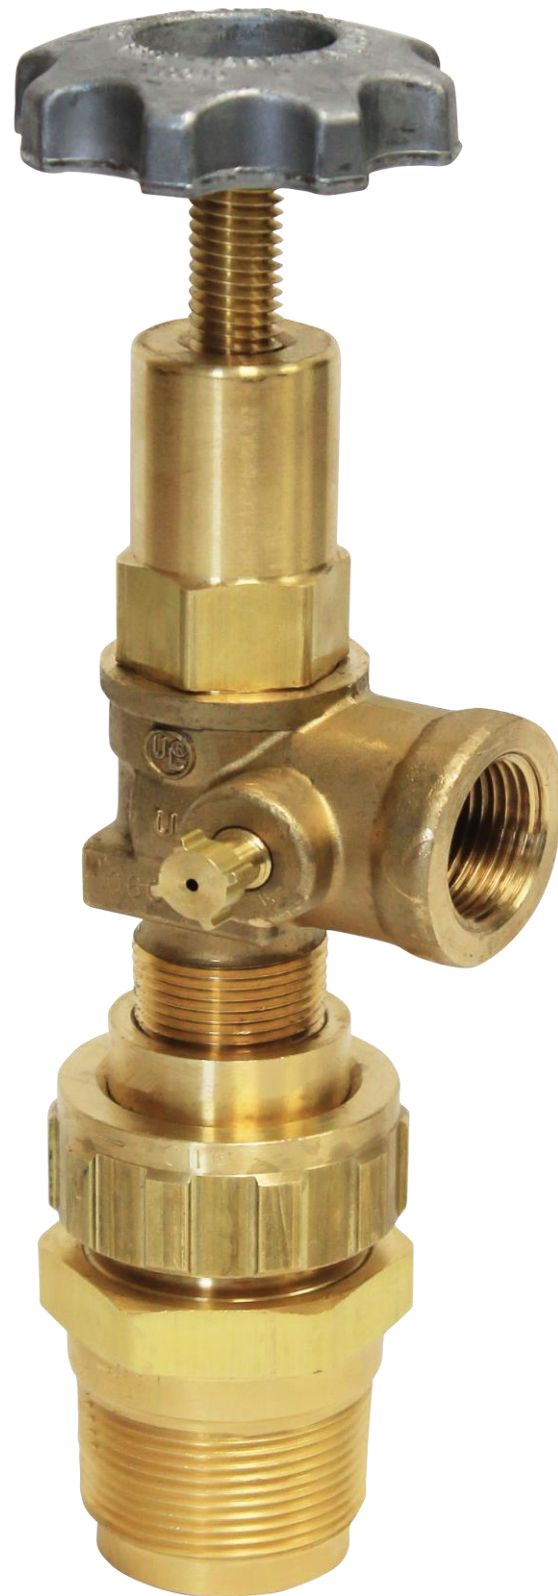
3121 & L7579

(Closed Position)

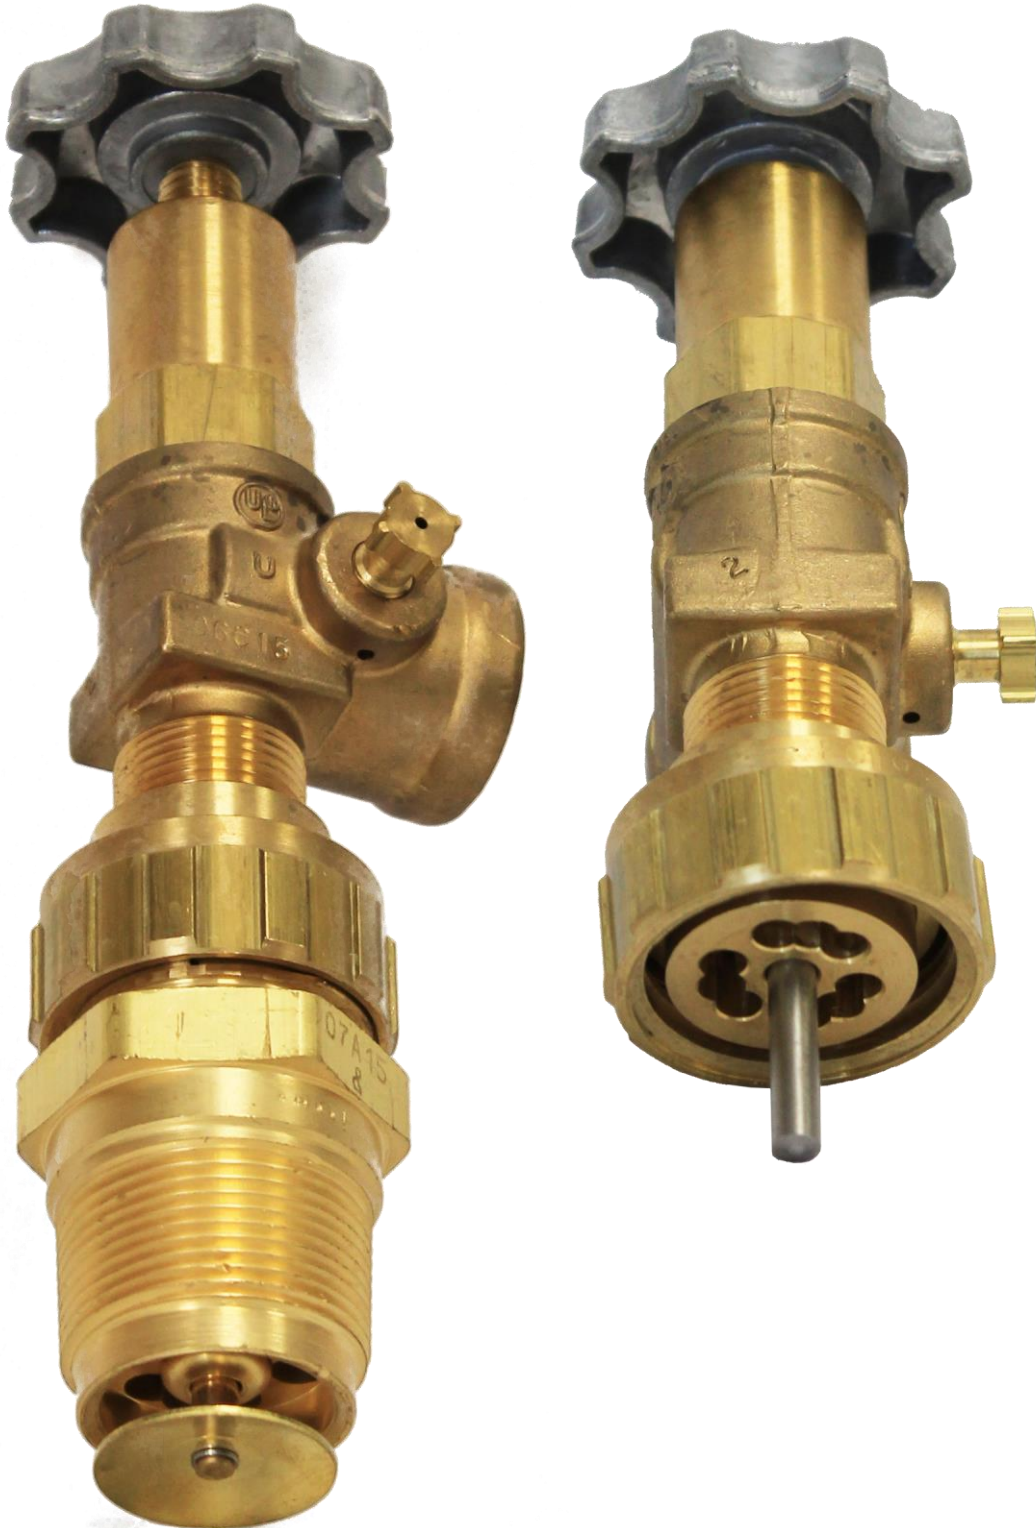
3121 & L7579

(Open Position)
